Service Bulletin

Subject: Driver Seat Memory Seat Switch Pushes into Door Trim Panel

Models: 2013 Cadillac XTS

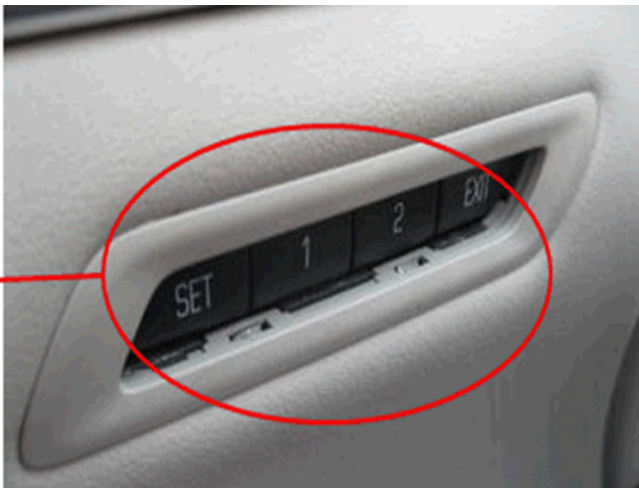
Some customers may comment that upon operating the driver seat memory seat switch buttons, the switch is pushing into the door trim panel.

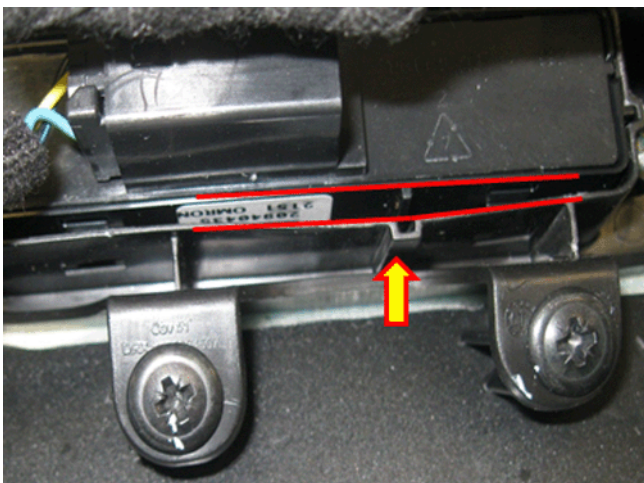
The cause of this condition may be insufficient retention of the seat switch snap features to the switch bracket.
