Service Bulletin

Subject: Brake Induced Pulsation/Vibration Felt in Steering Wheel, Rumble Noise from Underbody During Downhill Descent (Verify Condition and Replace Front Brake Pads)

Models: 2008 Chevrolet Silverado Light Duty (LD)
2008 GMC Sierra Light Duty (LD)
2nd-Design Only – w/ Pad Spreading Spring Clips (Refer to PIT4611 for Design Identification)
Equipped with Disc/Drum Brakes (RPO JF3) and Stabilitrak (RPO JL4)

2009-2013 Chevrolet Silverado Light Duty (LD)
2009-2013 GMC Sierra Light Duty (LD)
Equipped with Disc/Drum Brakes (RPO JF3 or JF7) and Stabilitrak (RPO JL4)

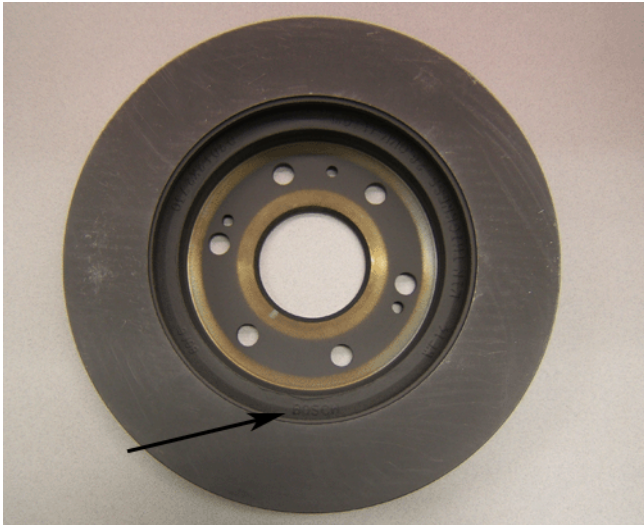
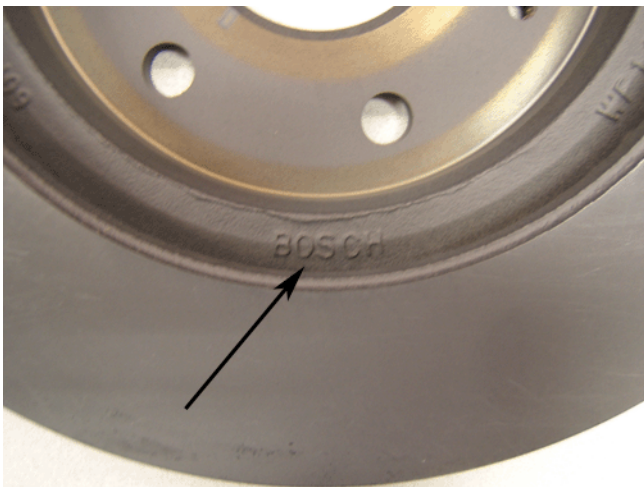
- It is critical to use the proper OEM brake rotors. Use of Non-OEM rotors may prevent the condition from being corrected long term.
 - If Non-OEM rotors are identified, these rotors are NOT covered under the GM New Vehicle Limited Warranty.
1. Inspect the front brake rotors to ensure that they are OEM rotors.
 - Remove the brake rotor from the vehicle.

- Inspect the back side of the rotor for the Bosch Logo. If the Bosch logo IS NOT present, replace with OEM GM rotors, P/N#25819670.
2. Inspect the front brake rotors for Assembled Lateral Runout (LRO) and thickness variation. Follow SI procedures.
 3. Inspect the front brake rotors for minimum thickness. Follow SI procedures.
 4. If the rotors are within specifications, DO NOT refinish or replace the rotors.
 5. If the rotors are out of specifications, refinish the rotors on a qualified lathe, or replace the rotors as appropriate. Follow SI procedures.
