# Service Bulletin No. 389

<b>MODEL</b> D / E / J Series Coaches	<b>TYPE</b> Field Change Program	<b>SECTION/GROUP</b> 7--Electrical	<b>DATE</b> Oct. 12, 2012
<b>SUBJECT</b> RETENTION NUT ON LEECE NEVILLE ALTERNATOR			
<b>CONDITIONS</b>

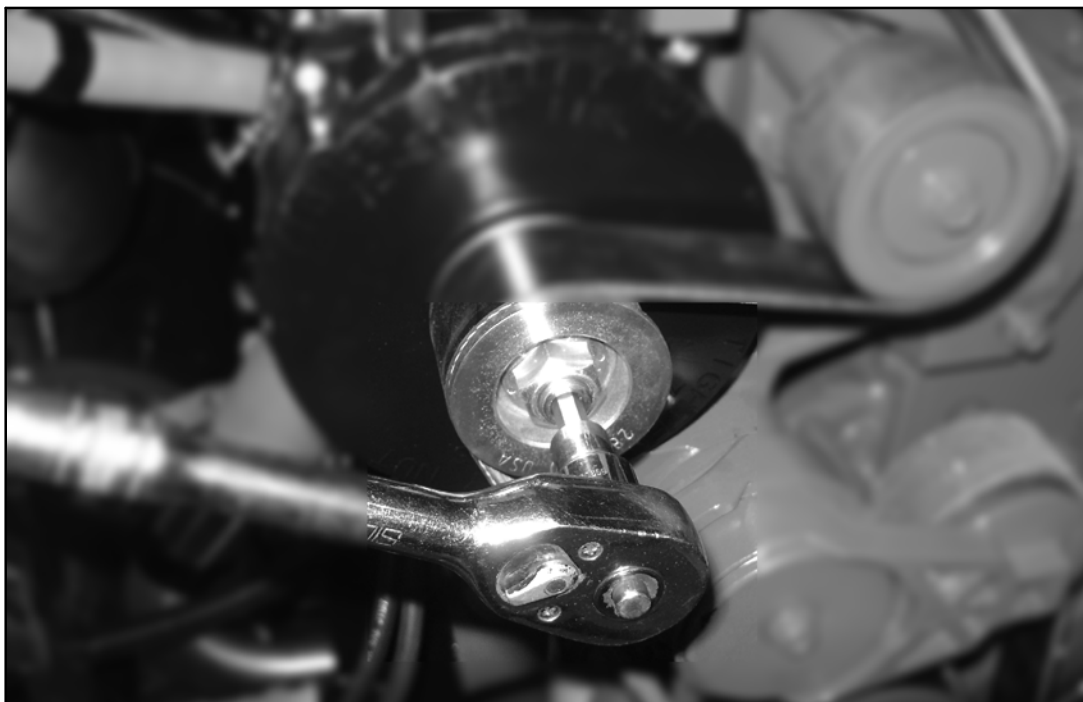
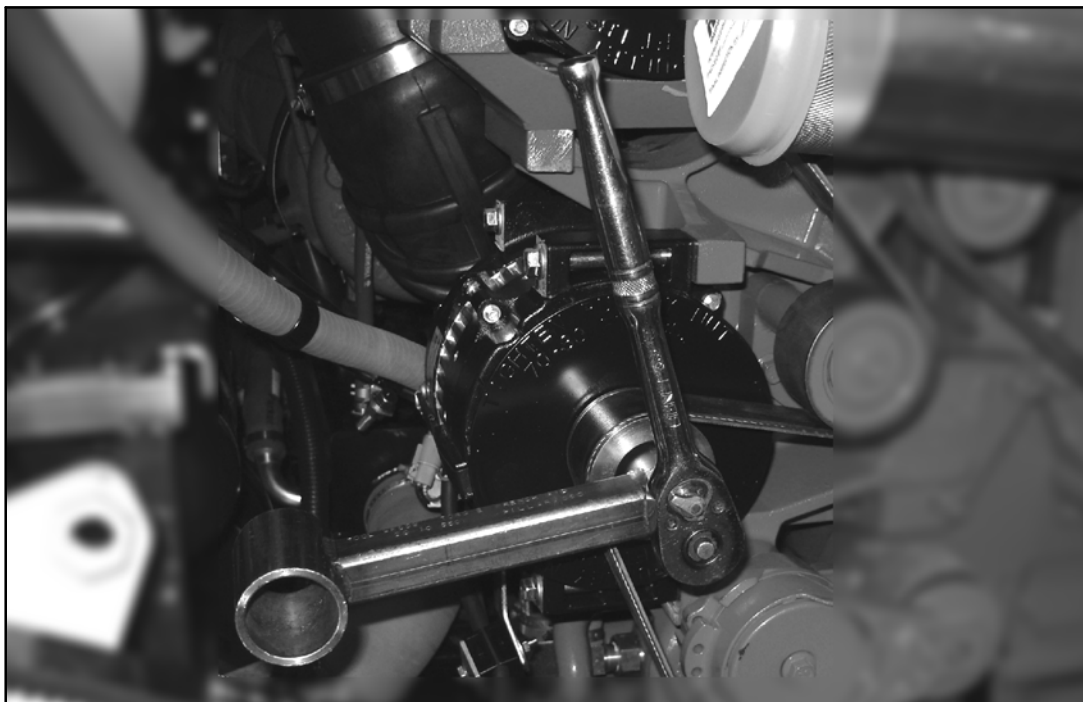
It has come to the attention of Motor Coach Industries, Inc. ("MCI") that the retention nut utilized on the Leece Neville alternator pulley installation is not maintaining the proper torque. The existing retention nut may result in alternator bearing failure.

Wrong retention nut for specific application.

**Figure 5. Reference photo.**

**Figure 6. Reference photo.**

9. Using the two ( 2 ) reference tools shown in Figures 5 and 6 simultaneously, remove and discard the existing pulley nut from the alternator.

10. Install and tighten the new nut, p/n 07-03-1285, on the alternator. Torque nut to 70– 80 ft.-lbs.
11. Repeat Steps 9. and 10. to the second alternator.

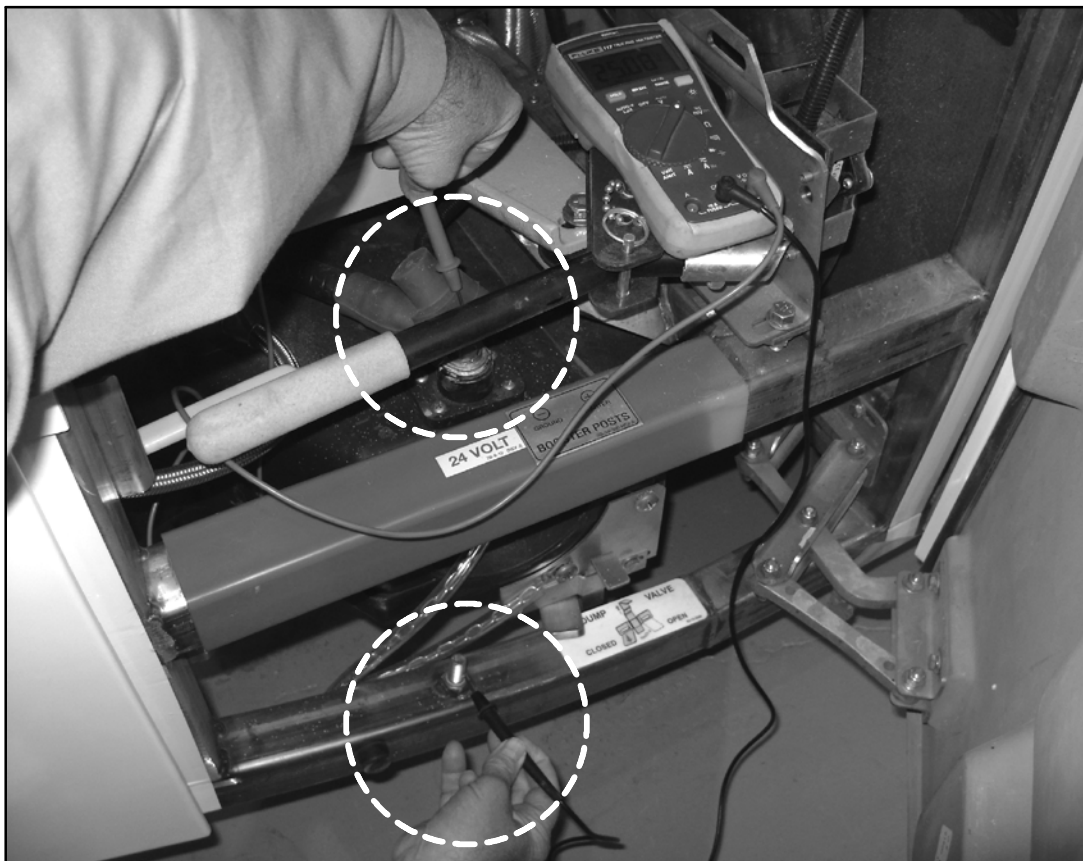
**Figure 7.**

***At full charge, the alternator's voltage should be between 28.0 and 28.4 volts.***

12. Using a ratchet and controlled force, carefully apply pressure to offset the clutch creating slack of the engine belt. Have a second person carefully orient and re-install the engine belt on the pulley(s).
13. Position the ENGINE RUN and ENGINE START switches on the engine compartment remote control box to the ON position. Position the main battery disconnect switch to the ON position.
14. Open the curbside, rear, side service compartment door. Locate the terminals and position a voltmeter across the jump start terminals ( refer to Figure 7 ) to validate that the charging system is operating.
