Service Bulletin No. 3074

MODEL E / J Series Coaches	TYPE Product Improvement	SECTION/GROUP 7 – Electrical	DATE Nov. 13, 2012
SUBJECT ENGINE HARNESS CLAMP			
CONDITIONS Parts may be purchased from MCI Service Parts, Louisville, Kentucky.

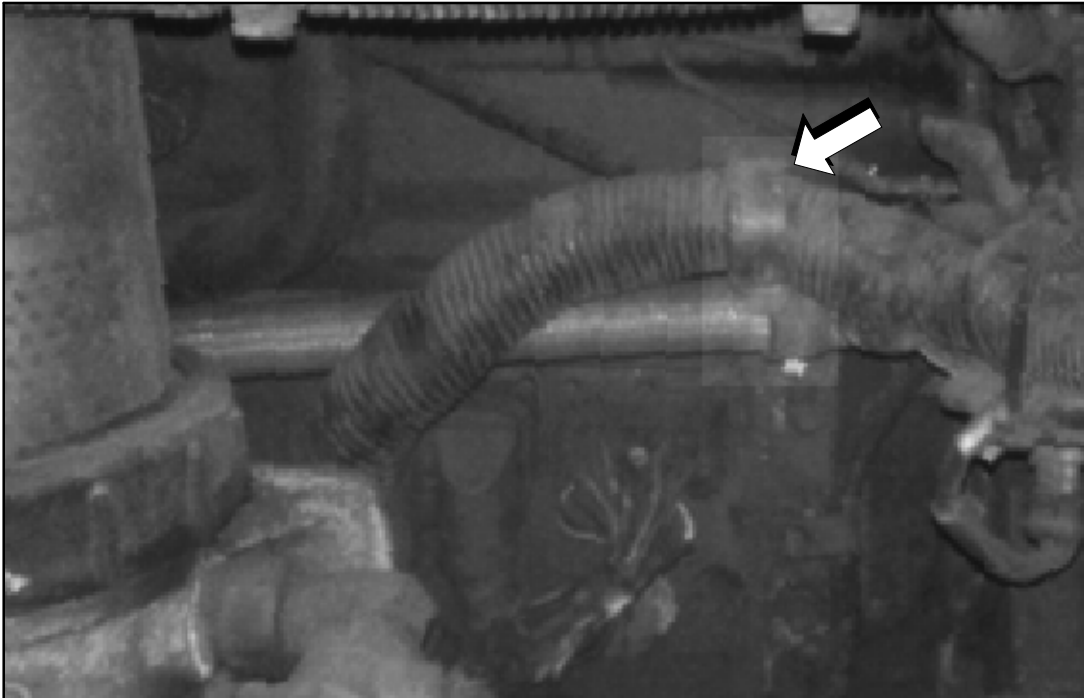
Figure 1. Curbside, rear, side service compartment.

The following MCI service bulletin outlines the necessary procedure steps to replace the existing 2007 EPA Cummins engine harness p-clip, in the event that loom damage or chafing has occurred.

3. Open the curbside, rear, side service compartment door.
4. Locate the engine harness shown in Figure 1.
5. Locate and remove the existing p-clamp and mounting hardware in the location shown in Figure 1. Discard the existing p-clamp and mounting hardware.
