Tech Tips

TT 61-12-01

2012-2013 EOS – Convertible Top Operation Stops, Trunk Does Not Lock Properly and/or Right Flap does not close

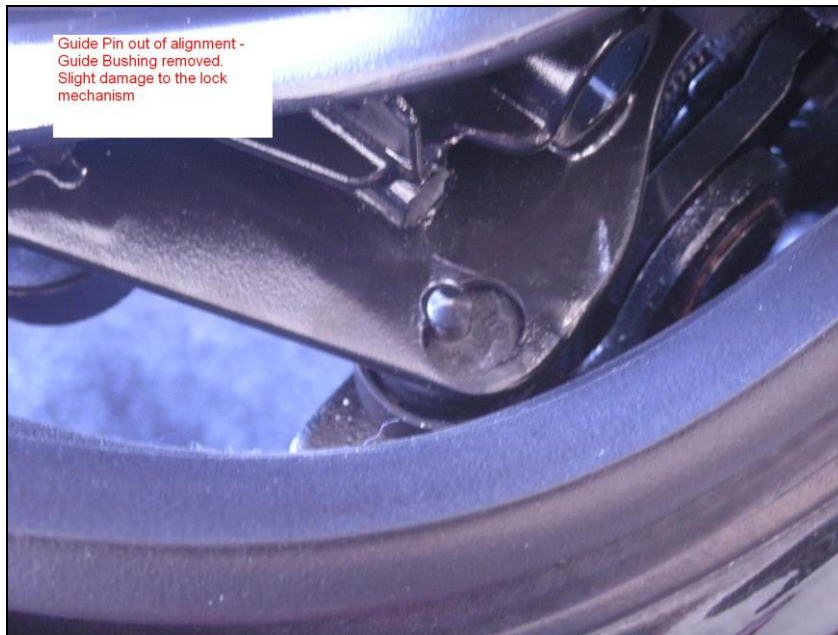
Some 2012-2013 EOS convertible tops may not function properly during opening or closing. The trunk lock operation may not complete, which can cause trunk to be inoperative and/or parcel shelf flaps to remain open when top opening cycle has completed. This may affect the G562, G563, or G564 sensors when running the test plan or looking at MVB 2. The guide bushing at the back of the lock mechanism (location circled in figure 1 below) may not align with the guide pin mounted on the body. It is necessary to remove trim on lock mechanism to inspect guide bushing. Misalignment of lock mechanism can cause damage to the guide bushing. The lock mechanism will need to be adjusted and the guide bushing replaced in most instances.

Figure 2: Guide pin out of alignment (shown with bushing removed)

To repair, open the trunk to access the underside of the parcel shelf. Remove the guide bushing if it is damaged. Loosen the 2 lock mechanism mounting nuts shown in figure 3 below on the underside of the parcel shelf (be sure to only loosen these 2 nuts due to pretension on the lock assembly). Adjust the locking mechanism so that the rear alignment guide pin is centered in the guide bushing hole. Resecure the 2 mounting nuts to 22NM. Close the trunk and cycle the top to check functionality. If the guide bushing was found to be damaged, replace with part number 1Q0898162A (see ETKA for latest supersession).

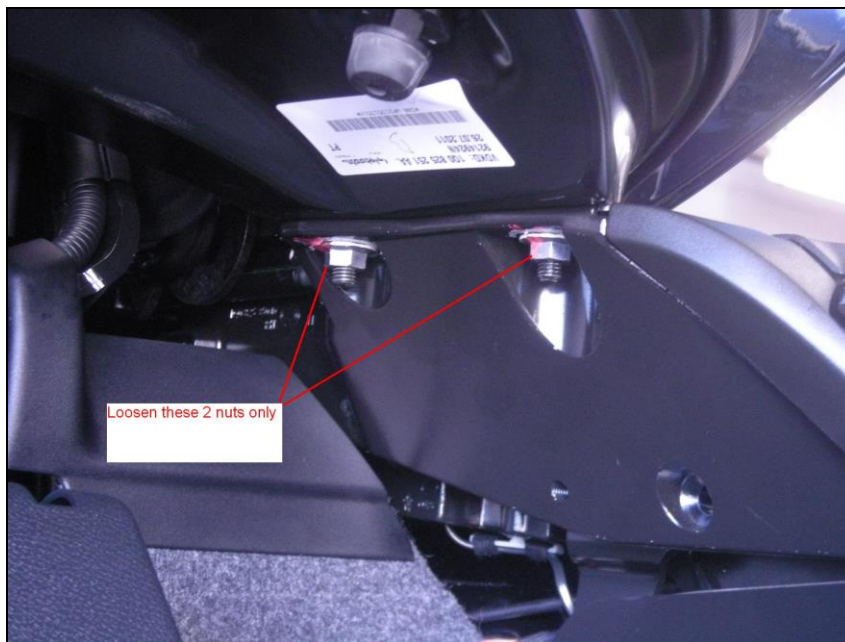
Figure 3: Lock mechanism mounting nuts

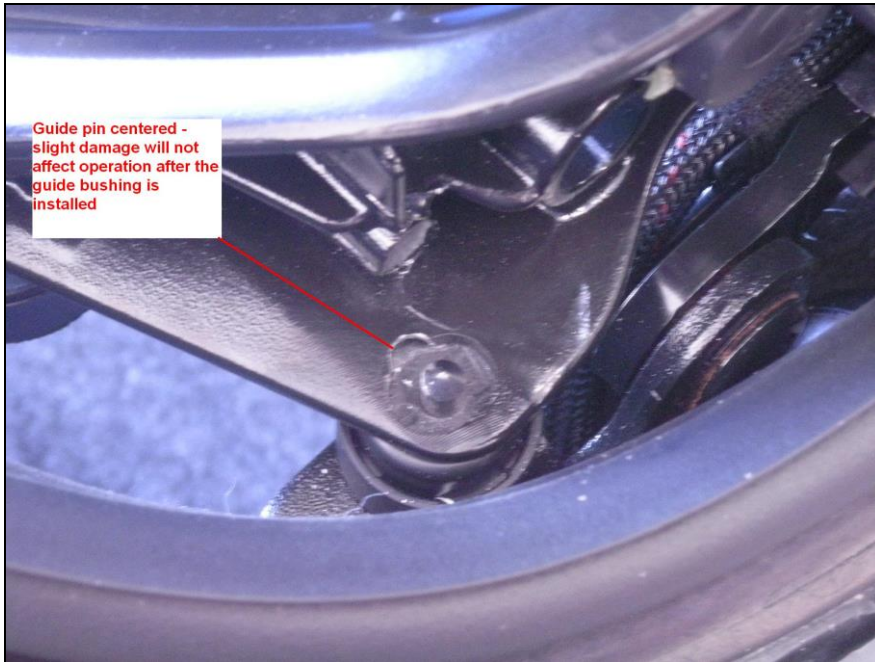
Figure 4: Guide pin centered after adjustment and before installation of new guide bushing.
