## Service Bulletin 451

November 2012

**Affected Models** .....Trophy SE  
**VIN Range** .....569806 to 571339  
**Markets** .....All Markets  
**Subject** .....Audio Software Update

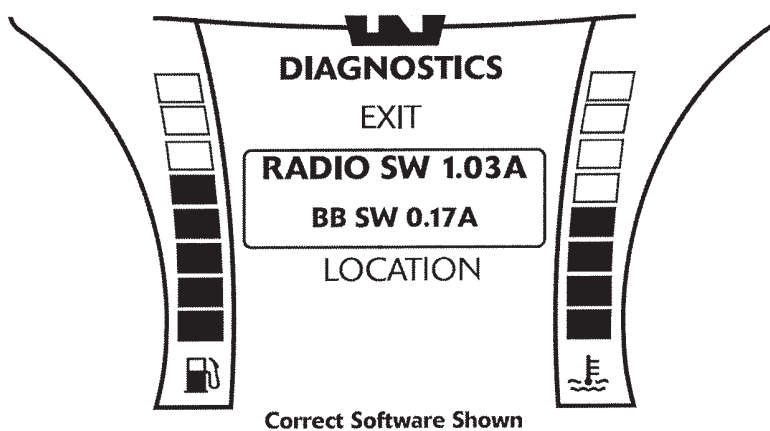
7. Press and release the instrument select button to show the software version.
8. If RADIO SW 1.03A is displayed in the top line of the boxed area, as shown below, the correct software is in the audio unit and an update is not required.

9. If any other software version is shown, the software must be updated.
