## Service Bulletin 476

**Affected Models** .....Trophy and Trophy SE

**Subject** .....Fascia Fixings

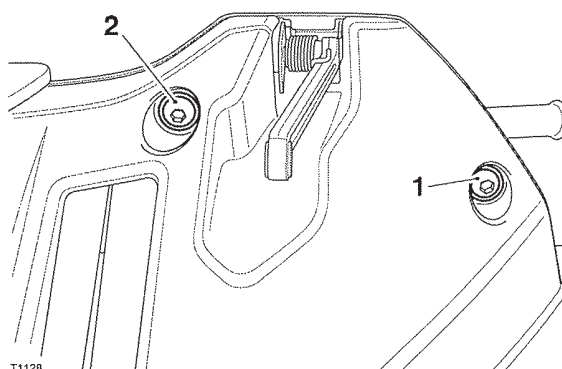
1. Outer fixing, left-hand side shown
  2. Patch-locked inner fixing, left-hand side shown
5. Fold out the rear view mirrors.

- **Note the location of the six non-patch-locked and the two patch-locked fixings for installation.**
4. Remove the four fixings securing the instrument fascia to the cockpit front panel. Retain the two inner (patch-locked) fixings as described in Parts Return Instructions on page 2.

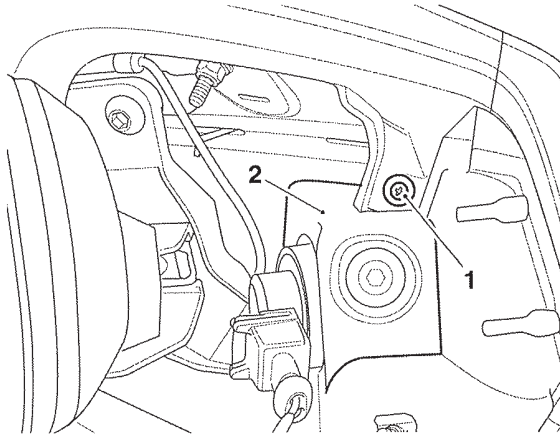
- **It is possible that on some earlier models the scrivet will be fitted in the opposite direction to that shown below. If this is the case, the scrivet must be fitted as shown below on installation.**

- 1. Scrivet, right-hand side shown**  
**2. Indicator housing**

6. Remove the two scrivenets (one on either side) located above the indicator housing.

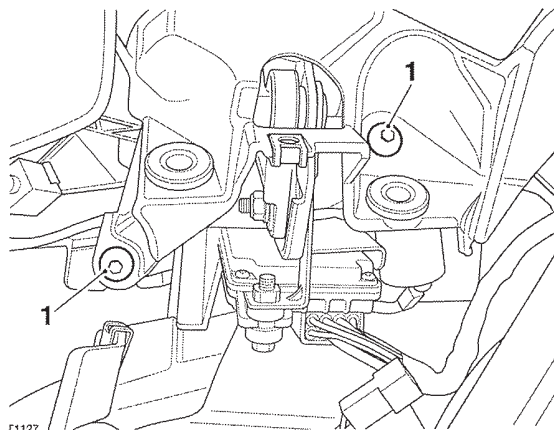
- 1. Fixings, left-hand side shown**

7. Remove the four fixings (two on either side) located behind the infill panels.

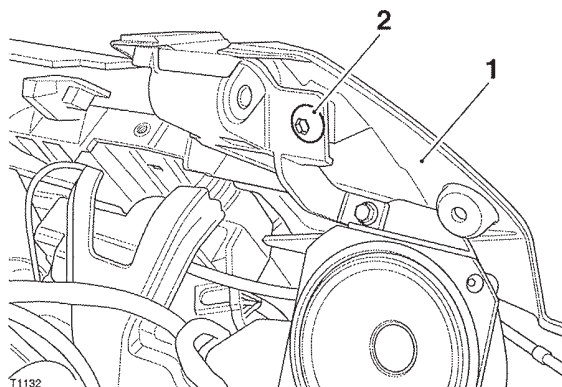
We have identified that there is a possibility that two upper fixings securing the cockpit front panel to its subframe may be missing on the above models. Dealers are requested to remove the instrument fascia and fit the two fixings.

### 1. Front cockpit panel

### 2. Fixing, right-hand side shown

1. Fit the fixings (part number T3330941) to secure the upper mountings of the cockpit front panel to the subframe.

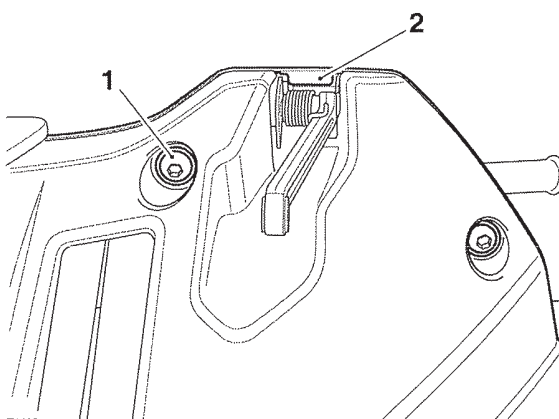
### 1. Patch-locked fixing, left-hand side shown

### 2. Instrument fascia upper tabs

2. Check that the XM antenna (US and Canadian models only) or the blanking cap (all other markets) is correctly located in the cockpit front panel.
3. Refit the instrument fascia upper tabs to the cockpit front panel, taking care to avoid damage to the mirrors. Check that the XM antenna or blanking cap is correctly retained.
4. Refit the six non-patch-locked fixings as noted for removal and tighten to **3 Nm**.
5. Fit the new patch-locked fixings to the two inner locations adjacent to the upper windscreen arms and tighten to **3 Nm**.

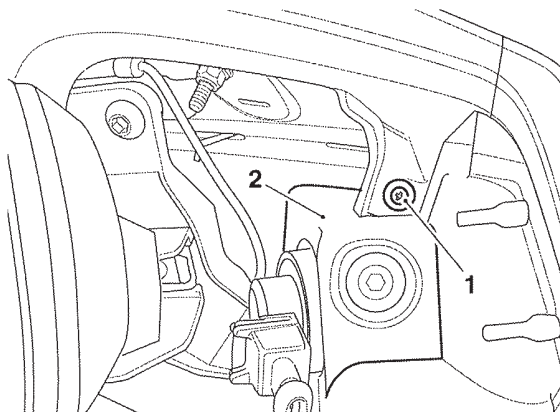
**1. Scrivet, right-hand side shown**

**2. Indicator housing**

6. Refit the two scrivets, as shown in the illustration below.
