Technical Service Bulletin

91 MMI3G+ Google Earth will not load (Zug 566)

91 12 70 2032240/1 December 21, 2012.

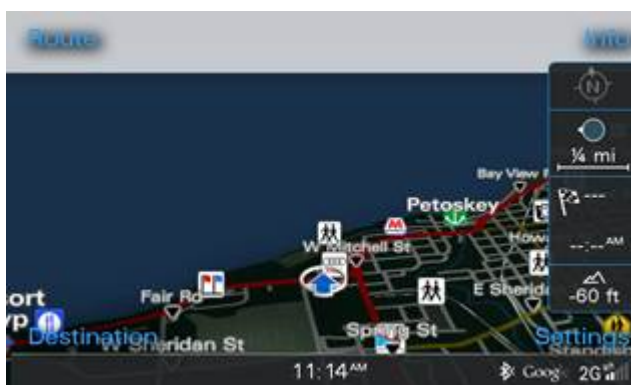
The Google Earth map will not load.
The display shows an active data connection, and 'Google' is almost fully white (Figure 1).

Figure 1. Google Earth will not load.

Certain Audi Connect partner carriers are transmitting data that is not supported by the MMI. The data disrupts the loading process of Google Earth and causes it to not completely load.

Instruct the customer that the issue is known and a solution is in development.

Do *not* replace any components. This TSB will be revised when a service solution becomes available.

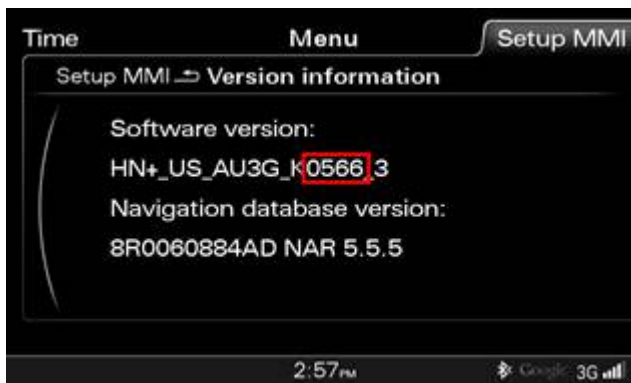
- The vehicle has MMI software 0566 installed (Figure 2). This can be located under *Menu >> Setup MMI >> Version information*.

Figure 2. Location of MMI software level.
