Technical Service Bulletin

35 0B5 7 Speed S-tronic, leaks from transmission

35 12 07 2028085/2 December 21, 2012. Supersedes Technical Service Bulletin Group 34 number 11-07 dated November 30, 2011 for reasons listed below.

Model(s)	Year	VIN Range	Vehicle-Specific Equipment
S4	2010-12	All	0B5 S-Tronic transmission
S5 Cab	2010-12

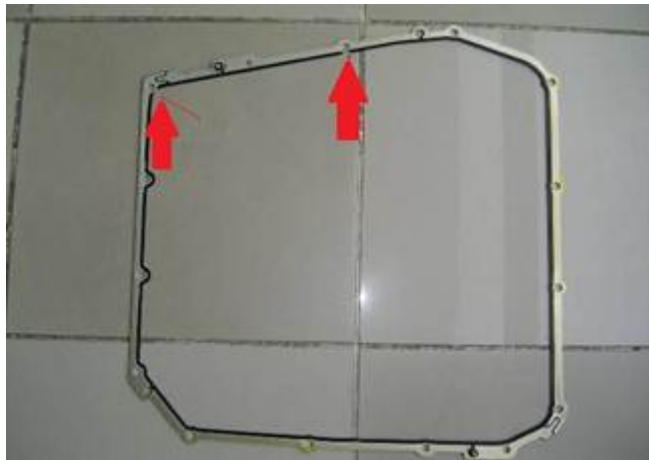
- Leaking from the oil pan seal.

Figure 1. Leak on the oil pan seal (red arrows).

4. Warm up the vehicle (test drive) and recheck for leaks.
5. If the leak is around the oil pan, remove the oil pan and check the gasket for imperfections or damage (Figure 1). If the oil pan is undamaged, only replace the oil pan seal.
6. If the oil pan is damaged as in Figure 2 or 6, check the mechatronics for loose bolts (Figure 5). Replace any loose bolts (Figure 5) and torque according to the repair manual instructions. Also, replace the pan and seal.

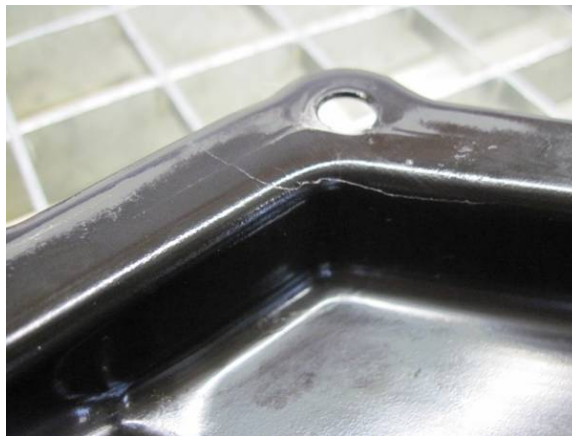
- Crack in the oil pan.

Figure 2. Crack in the oil pan.

7. If pan is cracked as in Figure 2, and no loose bolts on the mechatronics unit are found, replace oil pan and seal.

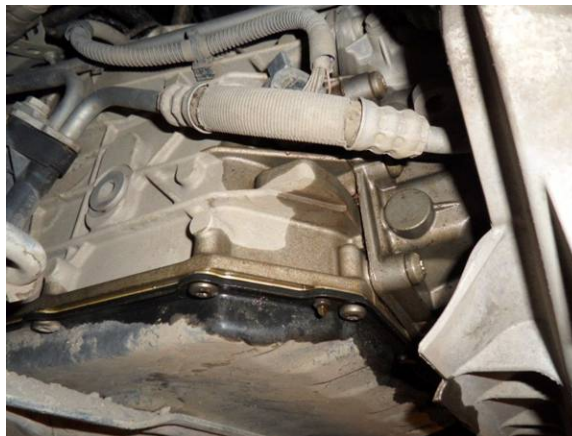
- Leak between gearbox housing and intermediate housing

Can be confused with O-ring of drain plug.

Figure 3. Leak between gearbox housing and intermediate housing.

8. If there is a leak between gearbox housing and intermediate housing as in Figure 3, reseal the case by following instructions in ELSA >> *Repair manual* >> *Transmission* >> *S Tronic Transmission Internal Components* >> *35 Gears, Shafts* >> *Removal and Installation* >> *Sensor Module with Transmission Input Speed Sensor -G612-, -G632-, -G676- and Circuit Board 3..*

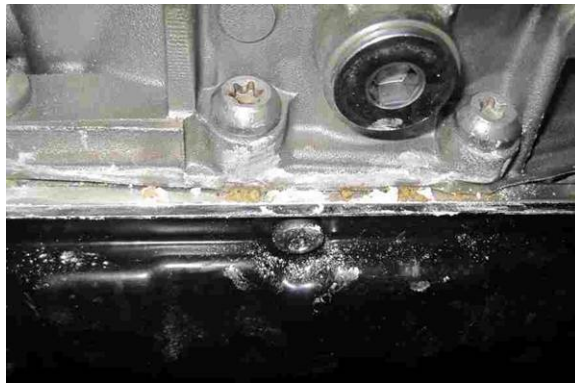
Figure 4. Leak located with Talcum spray.

1. Thoroughly clean the stained area.
2. Dry.
3. Apply talcum spray, or similar, (Figure 4) to the area that was stained with oil.

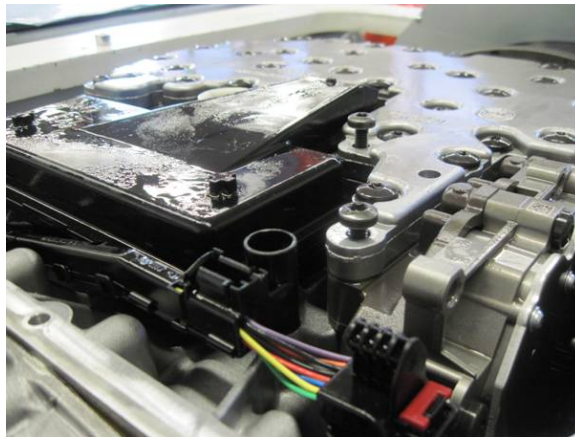
Figure 5. Loose bolts in the Mechatronics.

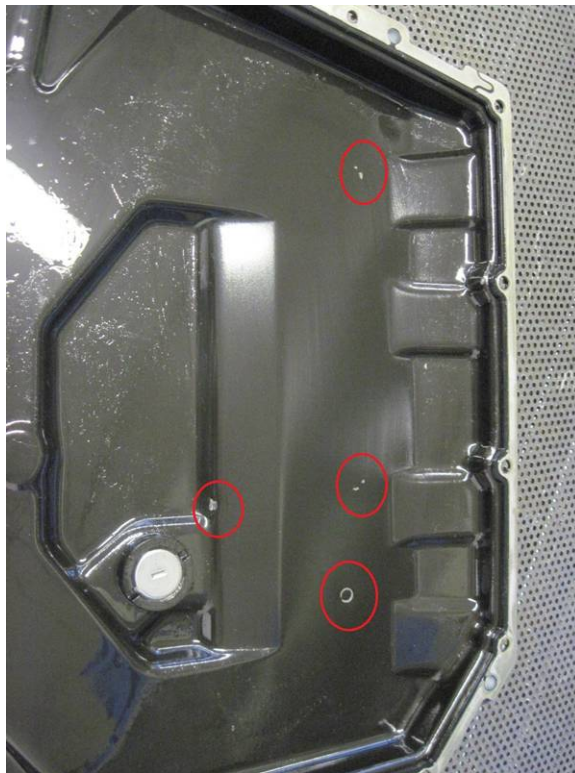
Figure 6. Damaged oil sump because of loose bolts.

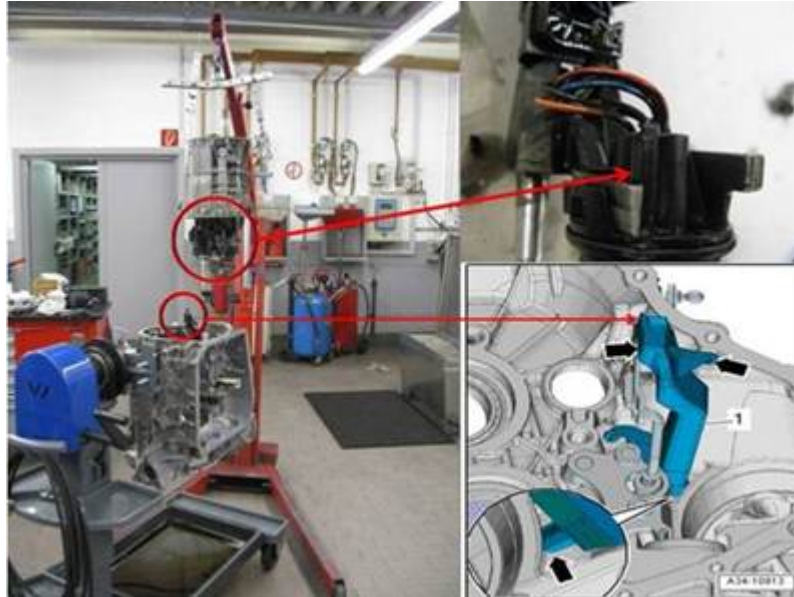
Figure 7. Caution points: Drip tray Sensor module connector.

Tip: Use caution when lifting or lowering intermediate housing to avoid damage to components (Figure 7).
