Technical Service Bulletin

91 Parking assistance provides false warnings

91 12 62 2024323/2 October 1, 2012. Supersedes Technical Service Bulletin Group 91 number 10 – 60 dated September 28, 2010 for reasons listed below.

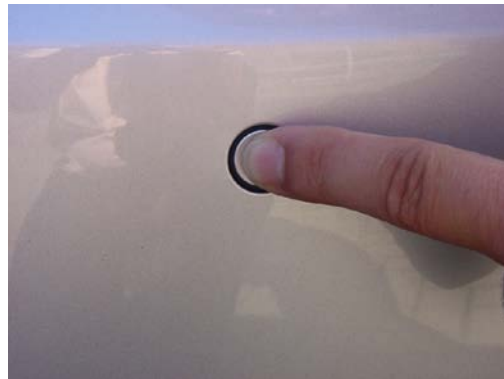
Figure 1. A pressure check on a parking aid sensor.

5. For 8-channel systems, check the installation of the front license plate holder for:
 - Protrusion. The license plate and holder must fit on flat.
 - Bent corners. Any bent-open corners may cause false readings.
 - Correct fit. Oversized license plate holders or frames can obstruct parking aid sensors.
6. Pressure check for a tight fit and correct attachment of the parking sensors. If the sensor is not snug or feels loose, remove the bumper and reinstall the sensor.

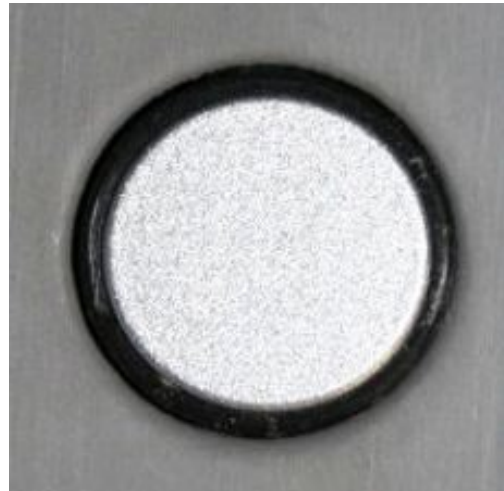
Figure 2. A correctly seated decoupling ring.

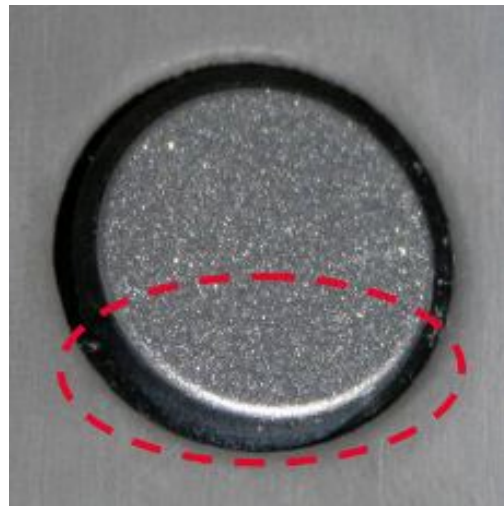
Figure 3. An incorrectly seated decoupling ring (bulging).

7. Check that the decoupling ring is correctly seated. If the ring is folded or bulging, remove the bumper and reinstall the sensor.

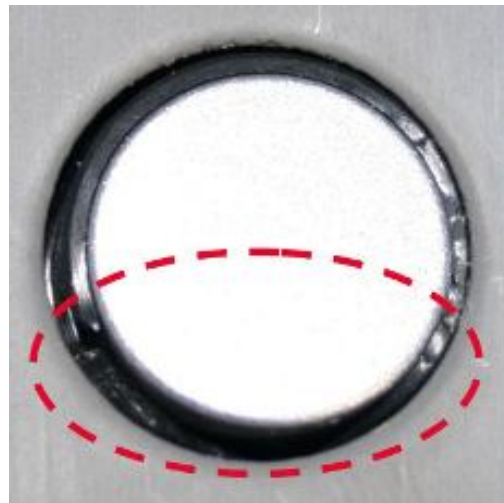
Figure 4. An incorrectly seated decoupling ring (folded).

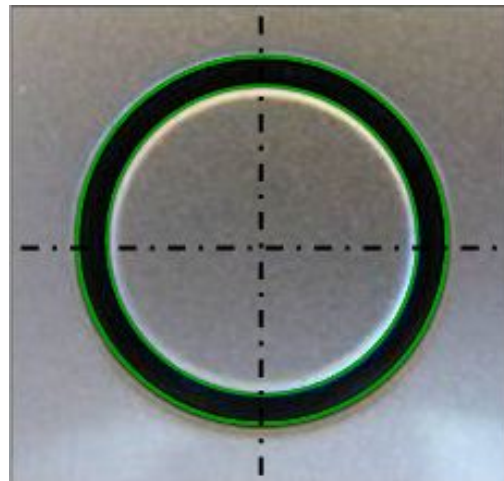
Figure 5. A correctly centered parking aid sensor.

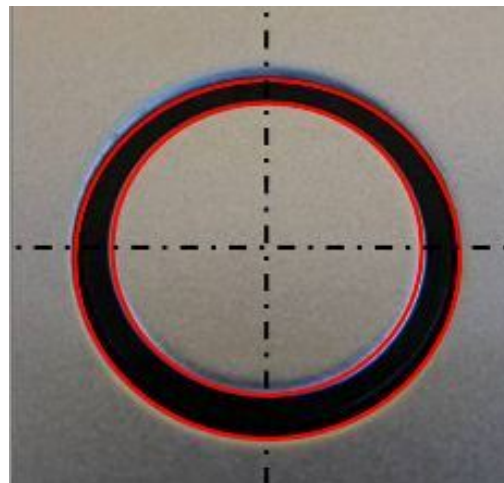
Figure 6. An off-center parking aid sensor.

8. Verify that the sensor is centered inside of the mounting hole. If the sensor is mounted off-center, remove the bumper and reinstall the sensor.

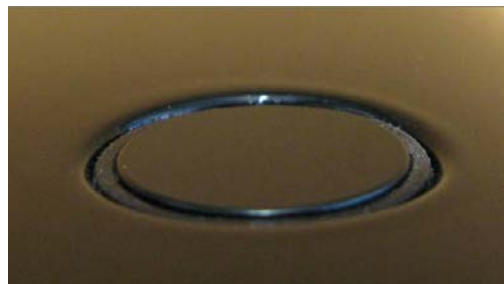
Figure 7. A correctly installed parking aid sensor.

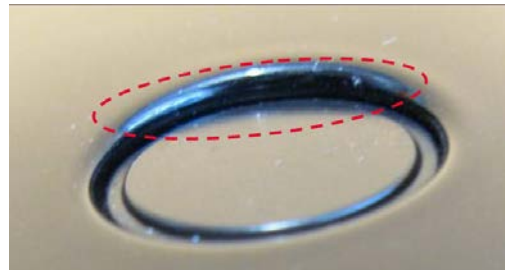
Figure 8. A recessed parking aid sensor.

9. Ensure the sensor sits flush with the bumper. If the sensor is recessed or bulging, remove the bumper and reinstall the sensor.

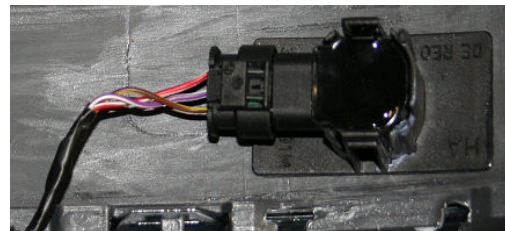
Figure 9. A correctly installed cable with sufficient length.

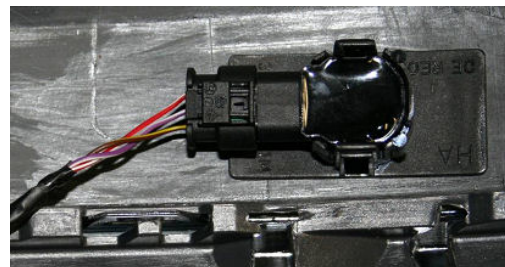
Figure 10. A sensor cable with insufficient length.

12. Check the cables in the bumper for damage and sufficient length. Cables that are too short can cause damage to the harness.
 - If the cable is damaged, repair the cable using VAS Repair Kit 1978.
 - If the cable is too tight, correct the routing by moving the support clip so the cable is no longer under tension.

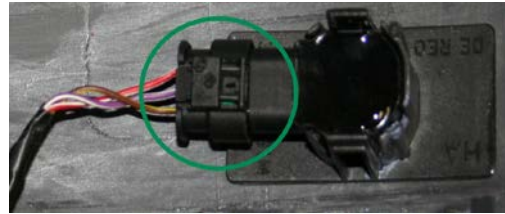
Figure 11. A correctly installed parking aid sensor connector.

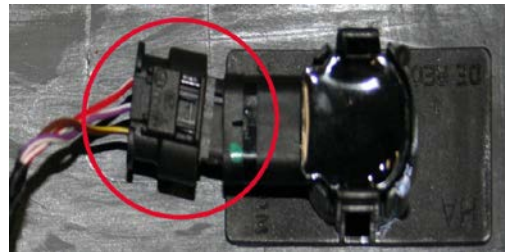
Figure 12. A parking aid sensor connector that is not seated correctly.

13. Check the connectors on the parking sensors and the socket box for correct installation. If the connectors are not installed properly, reinstall.
