Technical Service Bulletin

85 Passenger floor mat is wet

85 12 09 2029243/4 October 3, 2012. Supersedes Technical Service Bulletin Group 85 number 12 – 08 dated August 17, 2012 for reasons listed below.

Model(s)	Year	VIN Range	Vehicle-Specific Equipment
Audi Q5	2009 – 2012	All	Not Applicable

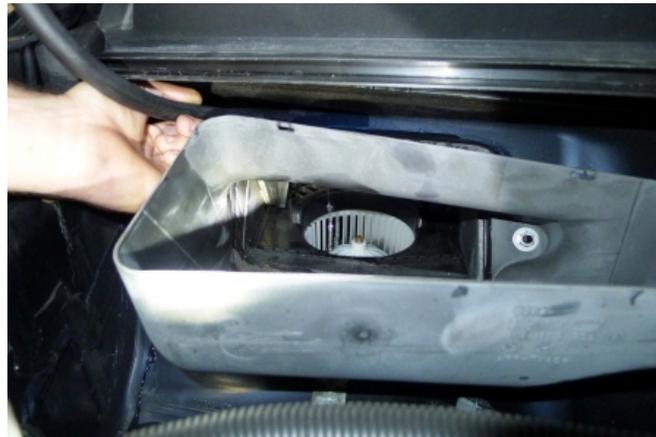
The flat surface of the fresh air intake may warp over time and cause a gap where it meets with the plenum wall. During heavy rains, water can back up and enter the vehicle through this gap.

2. After the plenum cover and fresh air intake grill have been removed, and before removing the fresh air intake, verify the customer complaint by applying water to the top surface where the fresh air intake meets the plenum wall using a hose. Visually check for water leaking into the blower intake. (Figure 1).

Figure 1. Applying water through a hose to check for water leaking into the fresh air intake.

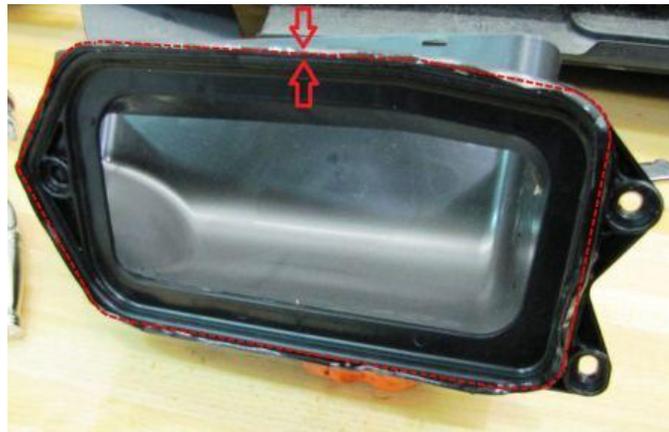
Figure 2. Location to apply the butyl cord is shown by arrows, and shown with the red dotted line.

3. Apply a bead of butyl cord around the perimeter of fresh air intake, to the outside of the existing rubber seal. (Figure 2).
