Technical Service Bulletin

48 Power steering warning in cluster, DTC for end stops

48 12 34 2029622/2 October 23, 2012. Supersedes Technical Service Bulletin Group 48 number 12-27 dated May 29, 2012 for reasons listed below.

Model(s)	Year	VIN Range	Vehicle-Specific Equipment
A6	2012	000001 - 999999	Not Applicable
A7	2012	000001 - 999999	
A6	2013	000001 - 043090	
A7	2013	000001 - 043090

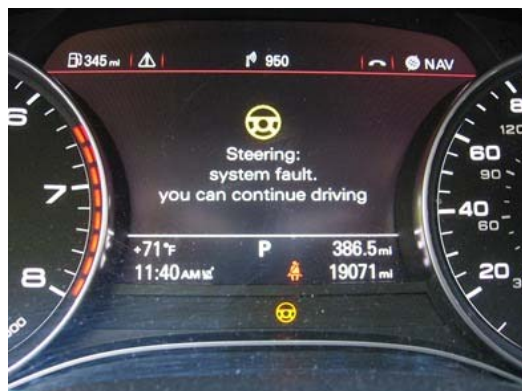
The yellow steering symbol is illuminated in the instrument cluster. A DTC *C10ACFO – steering end stops not programmed* is stored in address word 44 power steering (J500).

Figure 1. Yellow steering symbol and cluster message.

The steering control unit J500 expects to receive a VIN message over the data bus shortly after terminal 15 is turned on. If the VIN message is not received at the expected time, the J500 assumes it has been installed in a new vehicle and discards the programmed end position values.

Optimization of the VIN message handling was implemented with J500 software level 0009.

1. Follow all instructions in the attached TSB 2011732 *00 Software Version Management (SVM), operating instructions*.
2. Update the power steering gear control module (J500) using the SVM action code as listed in the table below if necessary.
