# Technical Service Bulletin

## 48 Symbol for dynamic steering in cluster (DTC 02538 001)

48 12 32 2029282/3 October 12, 2012. Supersedes Technical Service Bulletin Group 48 number 12 – 24 dated May 8, 2012 for reasons listed below.

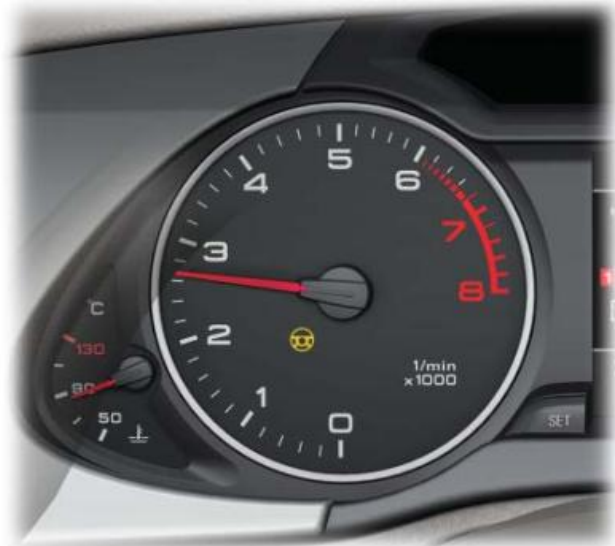
The symbol for dynamic steering is illuminated in the instrument cluster. A DTC for overload or overuse is stored in the active steering control module (J792), address word 1B. The environmental data from the GFF log matches the example shown in the Technical Background section.

Figure 1. Symbol for dynamic steering illuminated.

If the control unit for active steering -J792 stores a DTC 02538 001 *restricted function because of overuse* with environmental data that matches the example below, the control unit must be replaced.

Verify the customer's concern matches the Condition and Technical Background described in this TSB. Replace the control unit J792 according to the repair manual and **not** the steering column as described in the guided fault finding.
