Technical Service Bulletin

27 Excessive Voltage DTCs present in multiple control units

27 12 15 2031145/2 October 23, 2012. Supersedes Technical Service Bulletin Group 27 number 12-14 dated October 12, 2012 for reasons listed below.

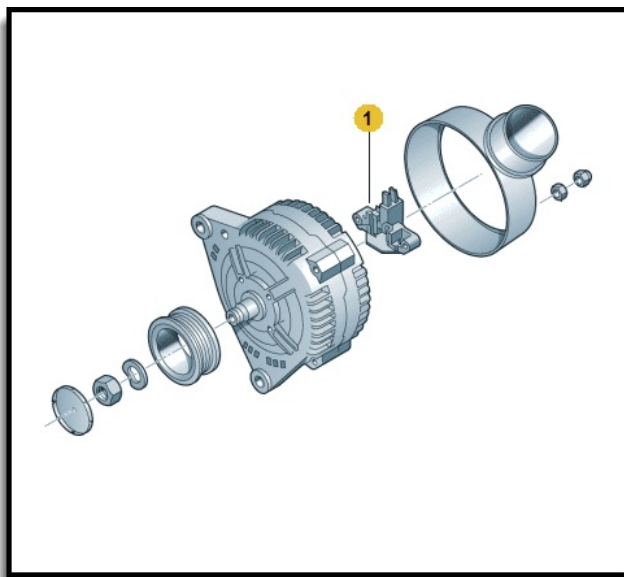
The voltage regulator on the alternator (Figure 1) can sporadically fail causing the electrical system to experience too high of voltage. As a result, the affected vehicle electronic components go in to high voltage protection and deactivate sensitive displays and indicators to prevent electrical damage. When an over voltage condition occurs the vehicle electronics and alternator are protected, **thus there is no need to replace the entire alternator assembly.**

Figure 1. Voltage Regulator (1) Mounted on the Alternator.

1. **ONLY** replace the voltage regulator and **NOT** the alternator assembly. The original alternator should function normally with the newer style voltage regulator fitted.
 - a. Different vehicles, even of the same model range and model year, can have different alternators from different vendors, i.e. Valeo, Bosch, or Hitachi. You must reference the actual part on the car and cross reference it with ETKA to determine which voltage regulator is required for the vehicle.
 - b. Replace the voltage regulator according to the ElsaWeb repair manual instructions.
*Repair Manual>>Electrical System>>Electrical Equipment General Information>>27
Battery, Starter, Generator, Cruise Control>>Removal and Installation>>Voltage
Regulator*

1. **ONLY** replace the voltage regulator and **NOT** the alternator assembly. The original alternator should function normally with the newer style voltage regulator fitted.
