# Technical Service Bulletin

## 94 Headlight Warning On in Cluster (Xenon Plus With or Without Adaptive Light)

94 12 99 2029194/2 November 30, 2012. Supersedes Technical Service Bulletin Group 94 number 12-74 dated April 23, 2012 for reasons listed below.

Model(s)	Year	VIN Range	Vehicle-Specific Equipment
Q7	2010-2014	All	Premium Plus and Prestige

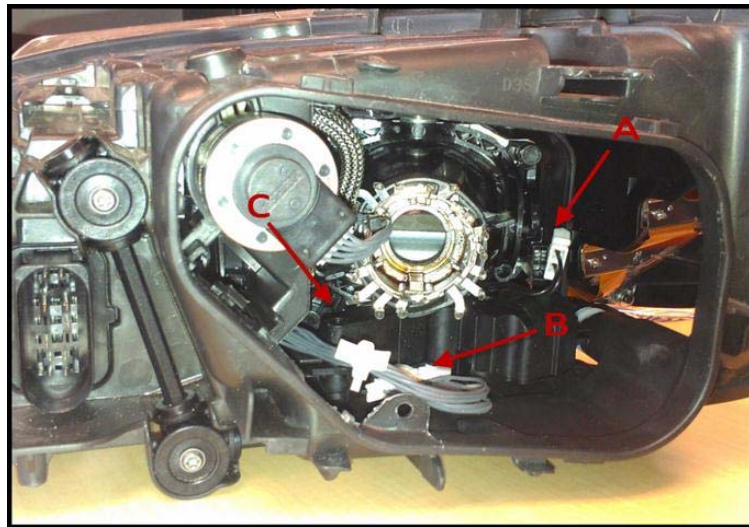
*Figure 1. Back of Tri-Xenon Headlight showing three connectors, “ A ” , “ B ” , “ C ” . Bi-Xenon Headlight will only have a single “ A ” connector.*

3. Physically check all the connectors inside the headlamp housing for proper seating and visually inspect the locks to ensure they are fully engaged.

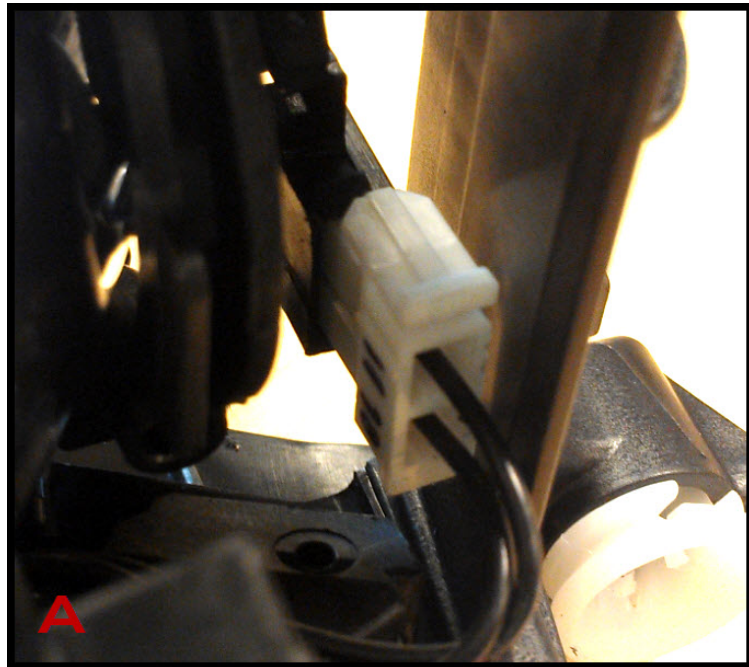
Connector “ A ” (Figure 2, A) can be seated but not fully engaged. When pushing on this connector the projector will swivel, thus you will need to hold the projector housing when applying pressure to the connector.

*Figure 2. Connector “ A ” shown not fully seated.*

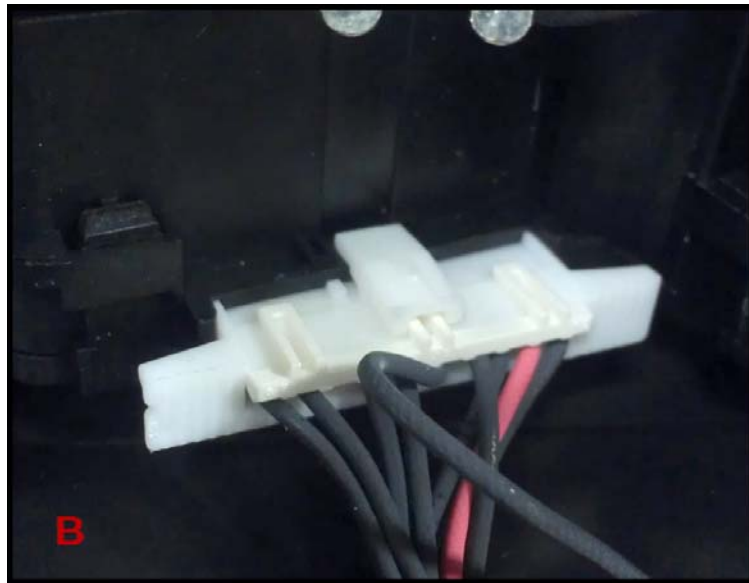
Connector “ B” (Figure 3, B) can be fully locked into place but it can be rotated 5-10 degrees off center. Thus, please check to ensure the harness connector is seated parallel to the connector housing on the headlamp.

*Figure 3. Connector “ B” shown off center.*

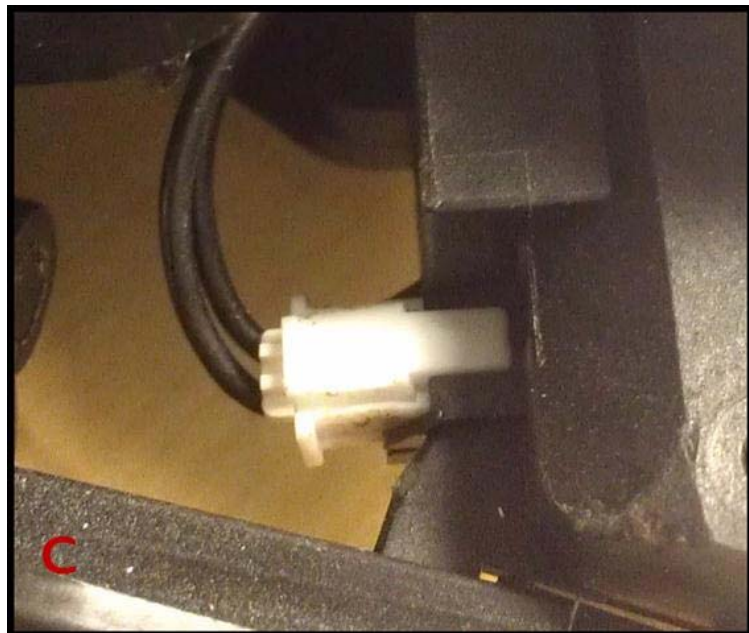
Connector “ C” (Figure 4, C) is located behind the motor mechanism, which rests below the projector lens. This is a very small two-pin connector. Take care when wiggling this connector because if it becomes fully disconnected, it is very difficult and almost impossible to reconnect without using special tools. Place your finger, or a set of small bent pliers, on this connector and pull towards yourself to fully seat the connector.

*Figure 4. Connector “ C” shown in the locked position.*
