# Technical Service Bulletin

## 91 Street address with hyphens cannot be used as Navigation destination

91 12 66 2027686/2 November 6, 2012. Supersedes Technical Service bulletin Group 91 number 11-15 dated October 5, 2011 for reasons listed below.

Model(s)	Year	VIN Range	Vehicle-Specific Equipment
A4	2011	All	MMI 3G/3G+ (Audi Navigation plus)
A5 / S5			
A5 / S5 Cabriolet			
Q5			
A6			
Q7			
A8

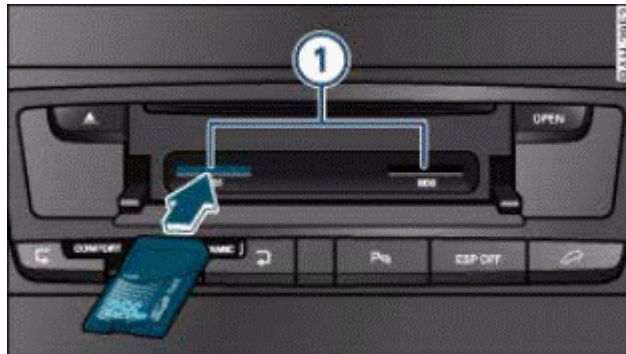
*Figure 1. Inserting SD card into slot 1 of J794.*

3. Insert the Navigation data SD card into SD slot 1 of the MMI main unit J794 located in the center of the instrument panel (glove box in A6 models).

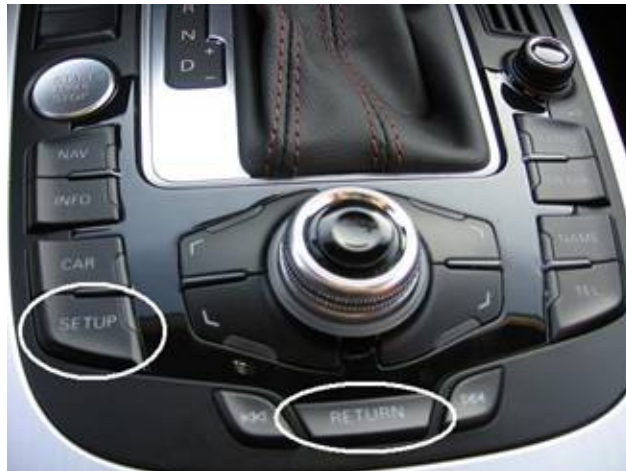
*Figure 2. SETUP and RETURN buttons.*

4. Press the **SETUP** and **RETURN** buttons simultaneously and hold both buttons down for about 5 seconds to enter the Engineering menu.

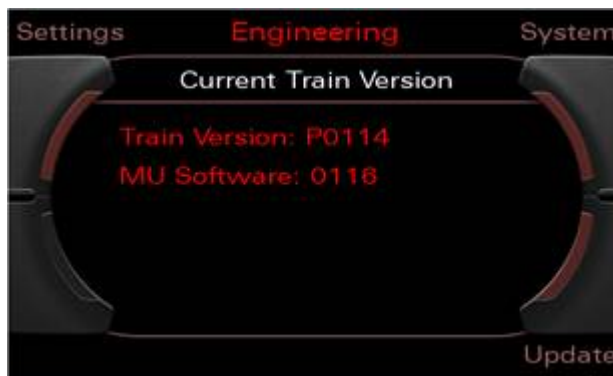
*Figure 3. Engineering menu.*

5. Once in the Engineering menu press the lower right MMI softkey to select **UPDATE**.

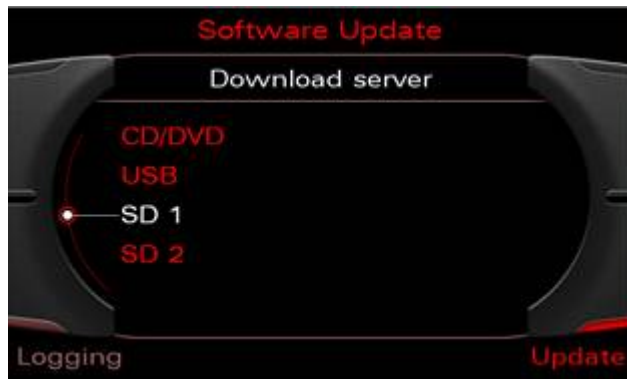
Figure 4. Selecting the correct media source.

6. Select SD 1 when prompted.

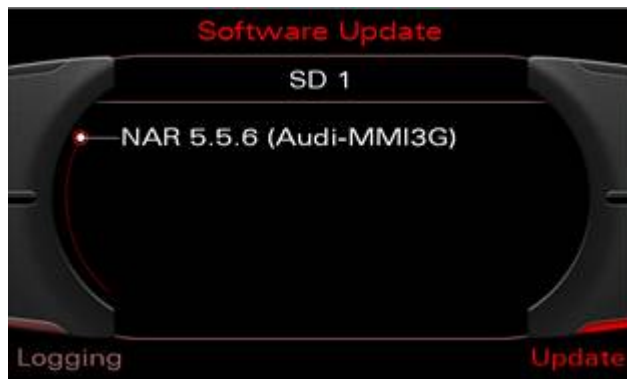
Figure 5. Selecting the navigation data compilation.

7. Select using the MMI control knob

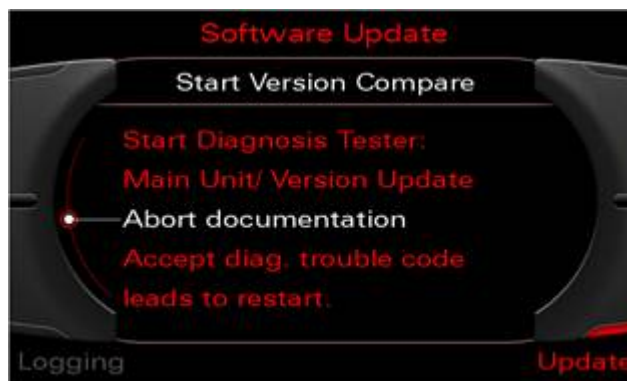
Figure 6. Selecting "Abort documentation" .

8. Start the update. The data transfer may take up to 2 hours (the update will continue automatically and does *not* require user intervention during this time).
9. Once the data transfer is complete, confirm the "Abort documentation" selection. The 3G MMI system will restart.

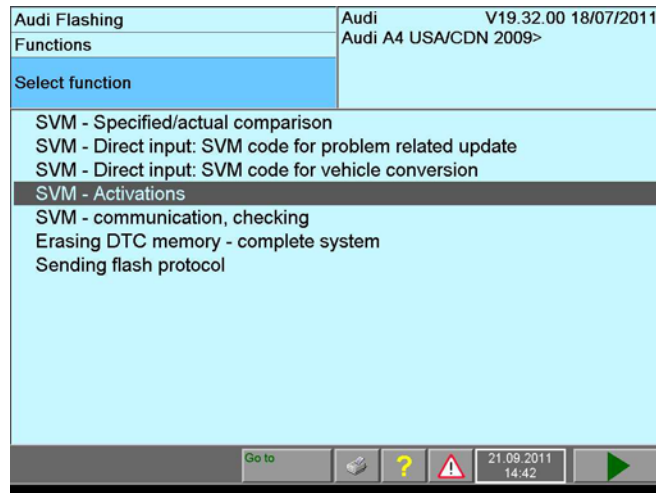
*Figure 7. Selecting the SVM – Activations test plan.*

11. Using the Audi Flashing function select and run the *SVM – Activations* test plan. A valid GeKo ID will be needed.

A valid activation code, activation number and PIN code from the Activation document will also be entered during the test plan.

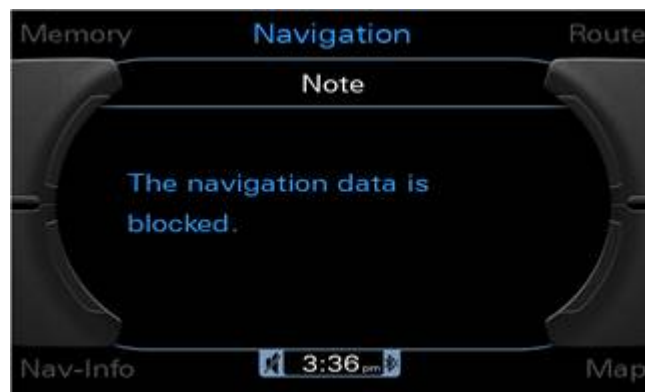
12. It is imperative the vehicle is *not* returned to the customer without performing the navigation data activation as the Navigation system will become unusable as the navigation data will be blocked.

*Figure 8. Navigation data blocked error screen.*

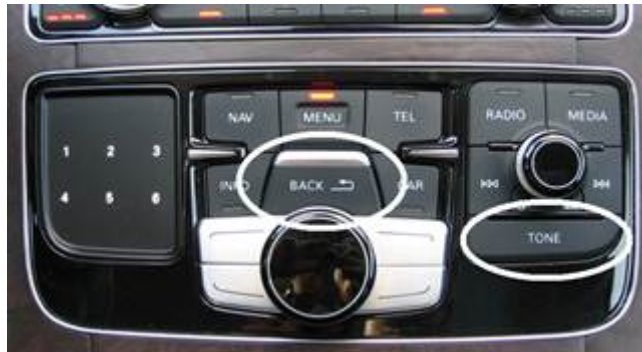
Figure

9. *BACK and TONE buttons.*

2. Press the **BACK** and **TONE** buttons on the front control panel E380 simultaneously and hold both buttons down for about 5 seconds to enter the Engineering menu.

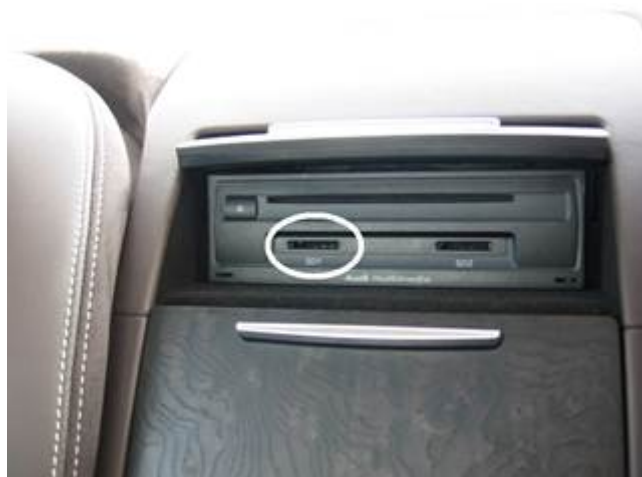
Figure 10. *SD card slot 1 of rear main unit J829.*

4. Remove the Navigation data SD card from the front MMI main unit J794 and insert it into SD slot 1 of the rear MMI main unit J829, located behind the cover between the rear seatbacks.

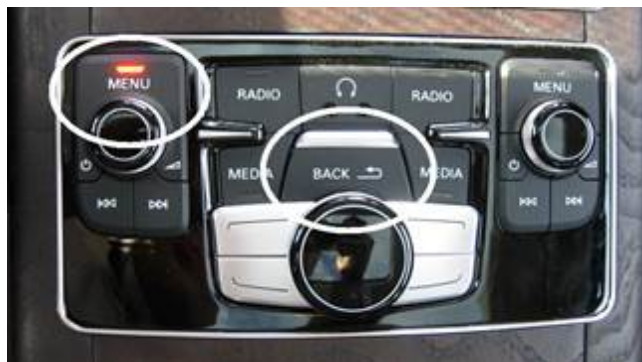
Figur

e 11. *BACK and MENU buttons.*

5. Press the **BACK** and **MENU** buttons on the rear control panel E499 simultaneously and hold both buttons down for about 5 seconds to enter the Engineering menu.
