# Technical Service Bulletin

## 72 Audi Q5 rattle from left rear seat back

72 12 04 2030729/2 November 30, 2012. Supersedes Technical Service Bulletin Group 72 number 12-03 dated September 5, 2012 for reasons listed below.

Model(s)	Year	VIN Range	Vehicle-Specific Equipment
Audi Q5	2009 - 2012	All	Not Applicable
	2013	000001 - 009164

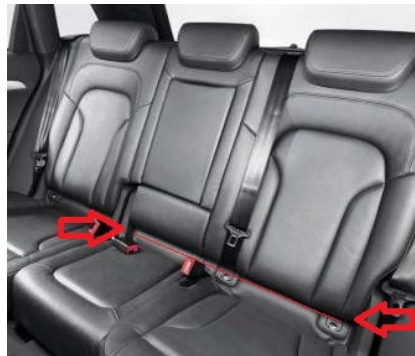
The rattle sound can be caused from the pivot point of the torsion bar (Figure 1) within the 2/3 rear seat backrest pivot assembly.

*Figure 1. Left rear seat noise area marked with red arrows.*

Improved 2/3 rear seatback frame torsion bar to pivot incorporating internal plastic guides. The striker pin has also been improved to reduce the contact surface with the lock.

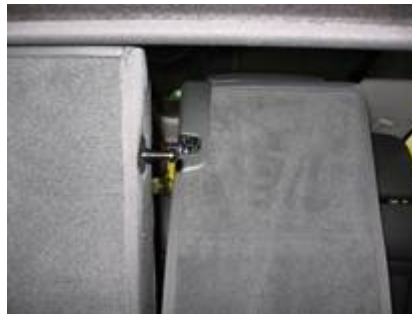
The squeak noise may be coming from the rear seat armrest area, specifically from the contact surface between the armrest lock and the striker pin.

*Figure 2. Armrest lock striker pin.*

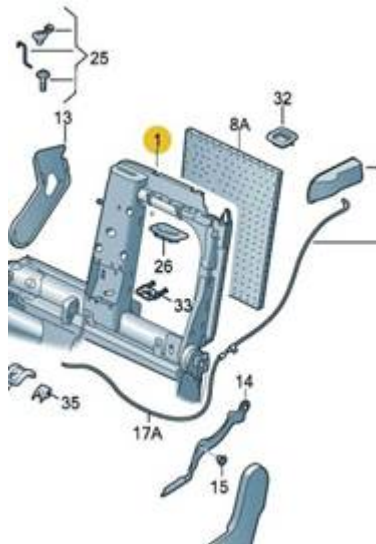
*Figure 3. 2/3 seatback frame.*

If a rattle noise is heard, start diagnosis by way of a test drive with a partner. Have your partner drive while you sit in the right rear of the vehicle leaving no objects or passengers in the left rear side of the seat. This rattle is best diagnosed under these conditions. If the source of the rattle is the 2/3 rear seatback, the 2/3 rear seat backrest frame torsion bar is not serviceable. The 2/3 rear seatback frame must be replaced.

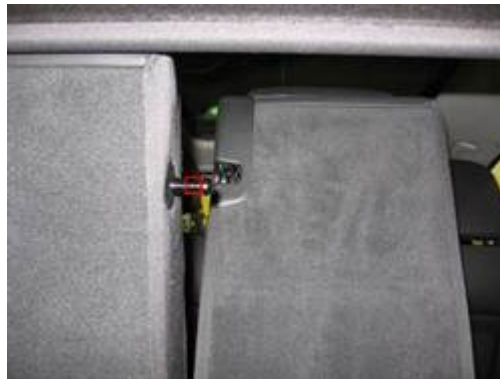
*Figure 4. Area of striker pin to be lightly sanded.*

Should a squeak be heard and it is determined that the source of the squeak is the armrest lock, lightly sand the contact surface of the striker pin to create a “knurled” effect.
