Technical Service Bulletin

64 Noises from front door or when lowering window

64 12 25 2027837/3 November 7, 2012. Supersedes Technical Service Bulletin Group 64 number 12-19 dated March 5, 2012 for reasons listed below.

Model(s)	Year	VIN Range	Vehicle-Specific Equipment
Q5	2009-2013	All	Not Applicable

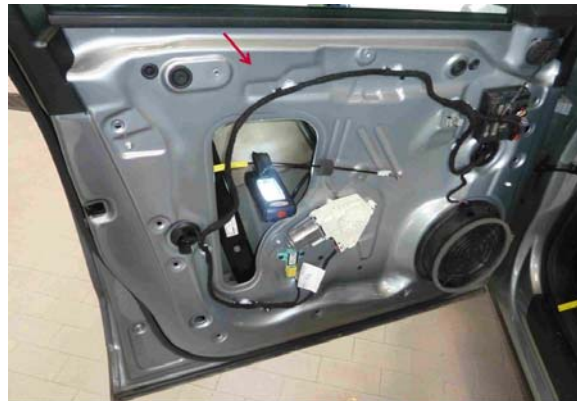
When lowering the window, it collides with the clip that holds the window guide cable. This causes the clip to open and contact the window during operation, or rattle while driving on rough roads.

Figure 1. Location of clip.

1. Remove the clip. The clip is inside the door (on the level of the red arrow) and is not visible from the outside (Figures 1 and 2).

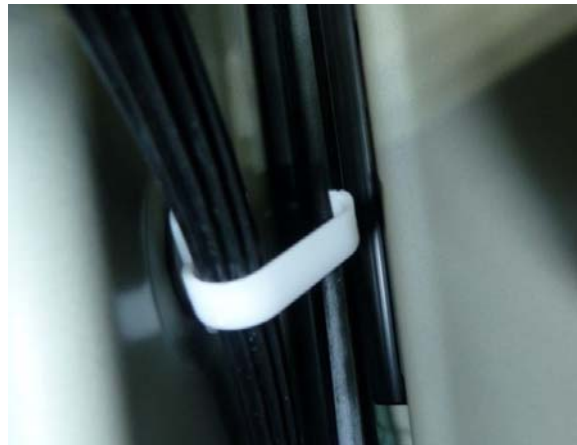
Figure 2. Clip as viewed from inside of the door panel.

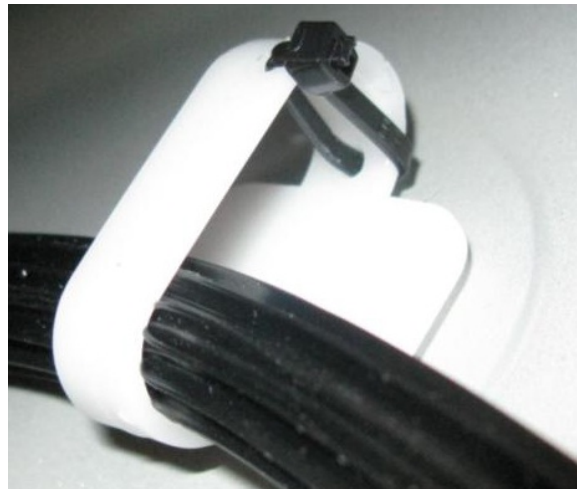
Figure 3. Clip with additional holes and zip tie.

2. Replace the clip with the parts included in the kit.
Put a zip tie through the two holes to prevent the new clip from opening. Trim the zip tie after installing it (Figure 3).

Tip: The kit includes a new clip with additional holes in it and a zip tie.
