# Service Bulletin

**Subject:** Diagnosis and Repair HVAC Blower Function

**Models:** 2008-2013 Cadillac Escalade Models  
2007-2013 Chevrolet Silverado  
2008-2013 Chevrolet Suburban, Tahoe  
2007-2013 GMC Sierra  
2008-2013 GMC Yukon Models  
All Built Prior to November 1, 2012

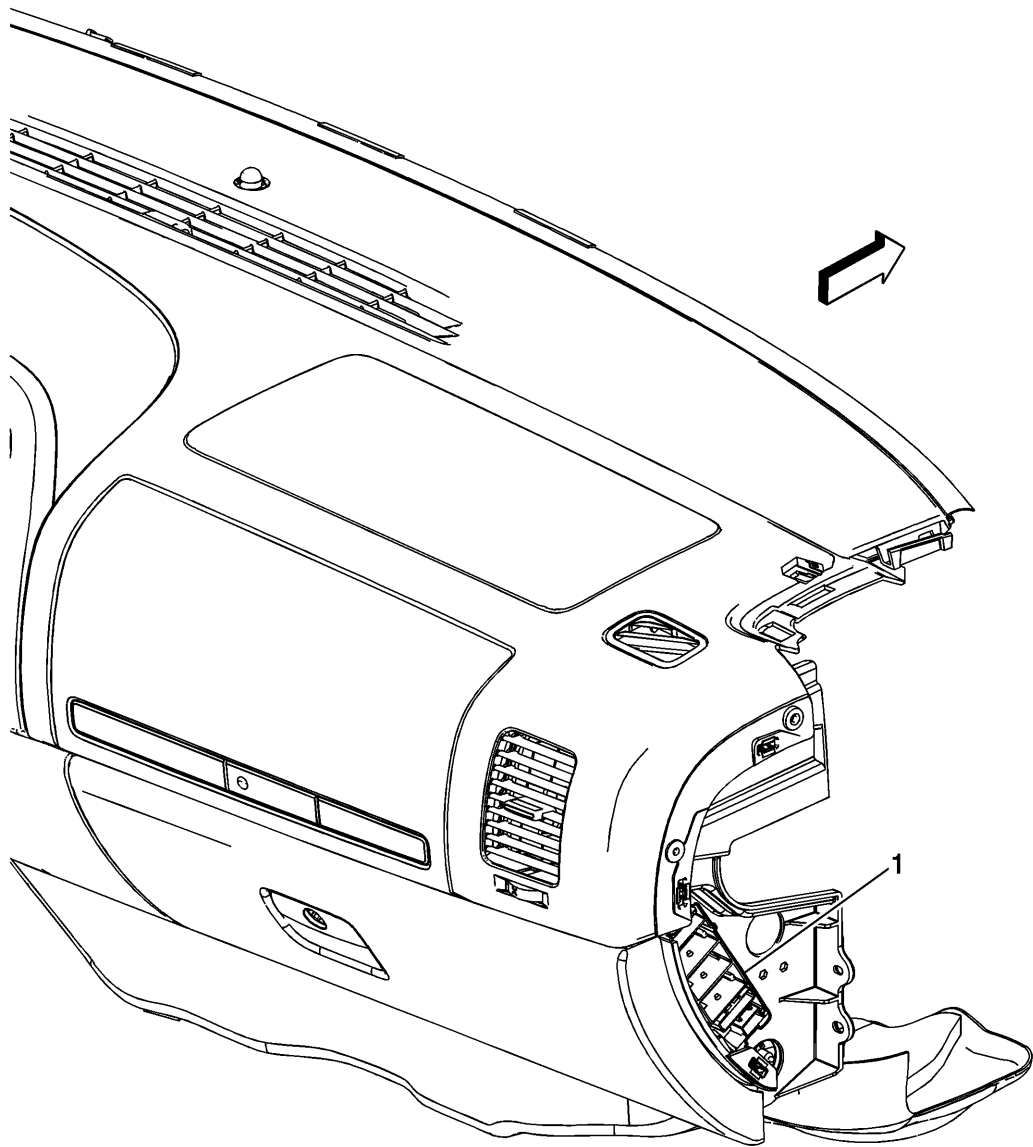
One possible cause of this condition may be the contacts in the HVAC junction block(s) located at the right side of the instrument panel.

1. Remove the cover on the right side of the instrument panel, exposing the junction blocks.

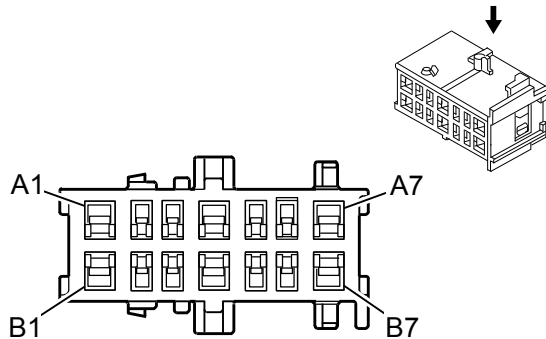
Use the following diagnostic and repair steps if the fault is determined to be caused by the X4 junction block.

1. Make sure there are no backed out or loose terminals using the appropriate Terminal Test Probe.

2. Locate Pin A6, Circuit 754.
3. Perform a pin drag test using test probe J-35616-2A (GY).
4. If the terminal fails the pin drag test, replace the terminal for Pin A6. Refer to Junction Block - Right I/P X4 in SI.
5. Cut off the terminal between the core and the insulation crimp to minimize any wire loss.
6. To minimize wire loss, remove only the insulation required.
7. Position the stripped wire in the terminal.

8. Hand crimp the core wings first.
9. Hand crimp the insulation wings around the cable.
10. Solder the hand crimp terminal.

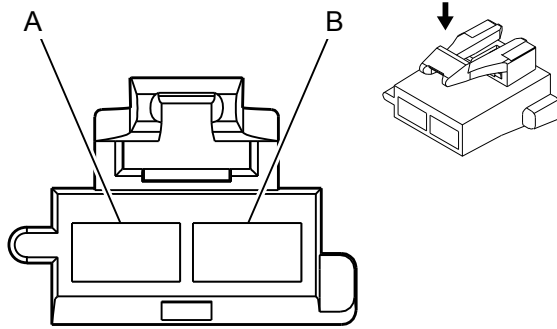
Use the following diagnostic and repair steps if the fault is determined to be caused by the X6 junction block.

1. Make sure there are no backed out or loose terminals using the appropriate Terminal Test Probe.

2. Locate Pin A, Circuit 542.
3. Perform a pin drag test using test probe J-35616-42 (RD).
4. If the terminal fails the pin drag test, replace the terminal for Pin A. Refer to Junction Block - Right I/P X6 in SI.
5. Cut off the terminal between the core and the insulation crimp to minimize any wire loss.
6. To minimize wire loss, remove only the insulation required.
7. Position the stripped wire in the terminal.
8. Hand crimp the core wings first.
9. Hand crimp the insulation wings around the cable.
10. Solder the hand crimp terminal.
