Service Bulletin

PRELIMINARY INFORMATION

Subject: Information on Seat Back of Driver and Passenger Front Seats Not Matching

Models: 2013 Buick Encore

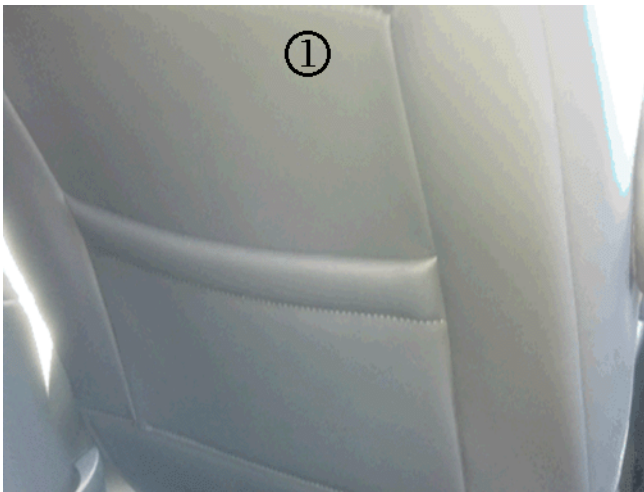
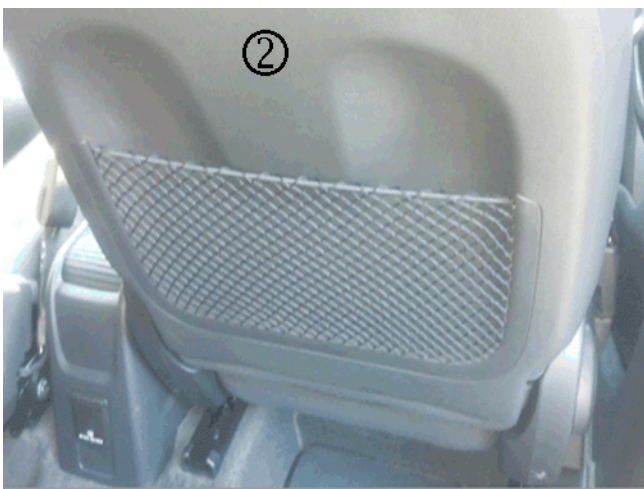
Some customers may comment that the seat back on the driver and passenger front seats do not match.

This occurs by design, with the driver non-folding seat (1) having a soft trim back cover and the passenger seat (2) having a hard plastic back trim protective purposes, due to its ability to fold flat.

This is a normal condition and NO parts should be replaced as an attempted correction.
