# SERVICE NEWS

**Bulletin:** SNV 11-09a  
**Date:** Nov 14, 2012  
**Valid to:** Pending  
**Replaces:** N/A  
**Priority:** **HIGH**

**Subject:** EGR Delta P ports

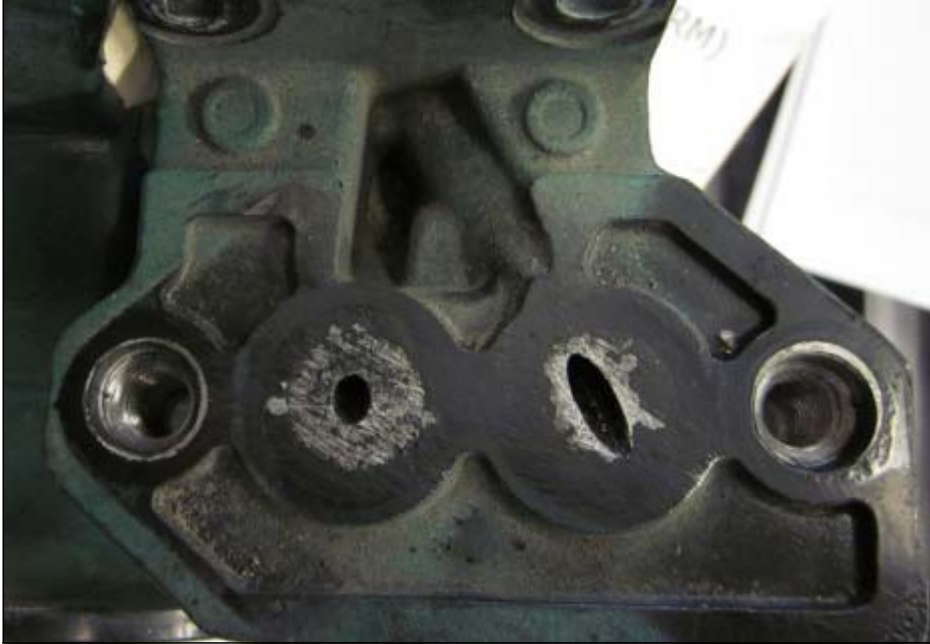
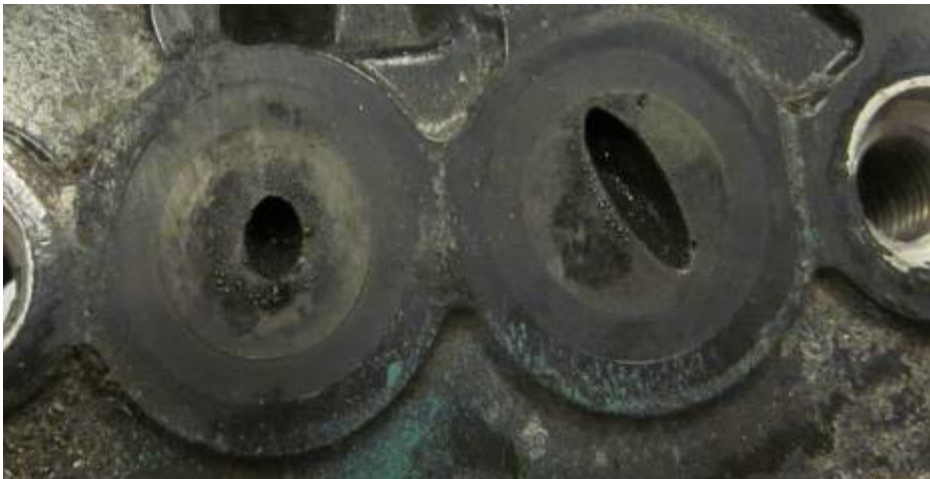
The mounting adaptor in the top picture is not to be reused. The mounting adaptor in the lower picture is borderline. If the coating comes off during proper cleaning then it must be replaced. The corrosive nature of EGR gases will attack the material now and may eventually cause a leak under the seals.

Clean the components with mineral spirits type parts cleaner and a rag. Carburetor cleaner can be used but must not be allowed to soak and must be blown dry after cleaning. For blockages use a Non-marring instrument like the end of a cotton swab, soft tooth brush (do not use a wire brush or scraper) to clear the ports. The dP tubes on the 11L engine can be cleaned with a piece of mechanics wire. If the blockages cannot be cleared or the coating is

damaged the component must be replaced. Mounting adaptor bolts for the 13L and 16L engines should be reassembled using Loctite 241 or 271 and torqued to proper specs 11L engines do not get Loctite applied.
