December 2012  
FL631AB  
NHTSA #12V-405  
Transport Canada #12-281

## Subject: Perpendicular Aluminum Air Tank Mounting Brackets

**Models Affected: Specific Freightliner 114SD, Business Class M2, Cascadia, and Coronado vehicles; Sterling 9500 vehicles; and Western Star 4700 vehicles manufactured July 29, 2008, through December 15, 2011.**

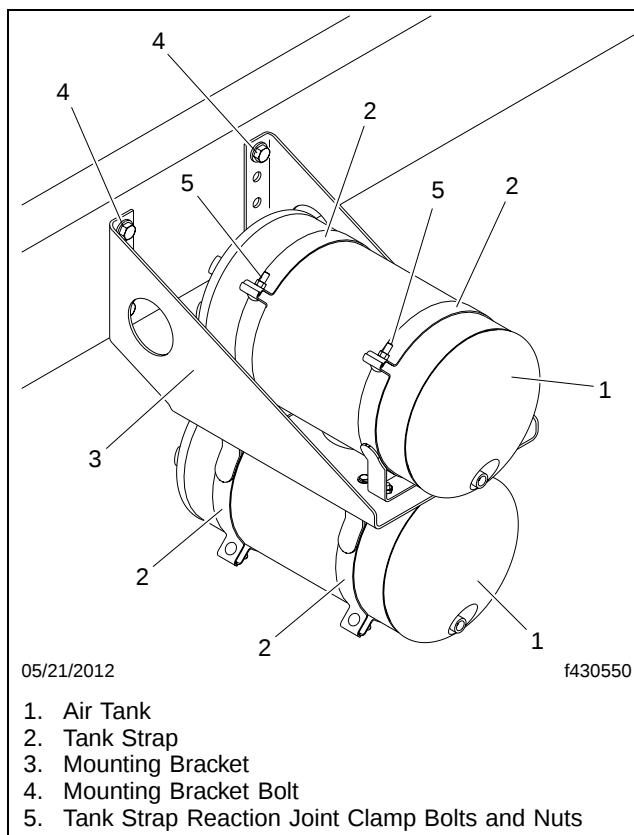
**Fig. 1, Perpendicular Air Tank Installation**

Certain perpendicular air tank mounting brackets may develop cracks under some conditions. Increasing size of the cracks may lead to air tank brackets separating from the frame rails which may lead to a loss of air in the air brake system, possibly leading to increased stopping distances. Air tanks that become separated from a moving vehicle may create a road debris hazard, increasing the risk of a crash.

7. Remove the aluminum air-tank mounting bracket from the frame rail.
8. Install the new steel air-tank mounting bracket on the frame rail. Tighten the mounting bolts and nuts 120 to 150 lbf·ft (163 to 203 N·m).

9. Lower the battery box, and install the fasteners. Tighten 120 to 150 lbf·ft (163 to 203 N·m).
10. Install the batteries and the battery box cover.
11. Remove the air tank cradles from the aluminum air tank mounting bracket and install them on the new steel bracket. Tighten the mounting bolts and nuts 25 to 31 lbf·ft (34 to 42 N·m).

12. Position the tanks in the cradles on the new mounting bracket and install the straps and fasteners. Tighten the reaction joint clamp bolts 26 lbf·ft (35 N·m).
