Coronado  
Business Class M2  
> Cascadia  
108SD/114SD

Freightliner  
Service Bulletin

## General Information

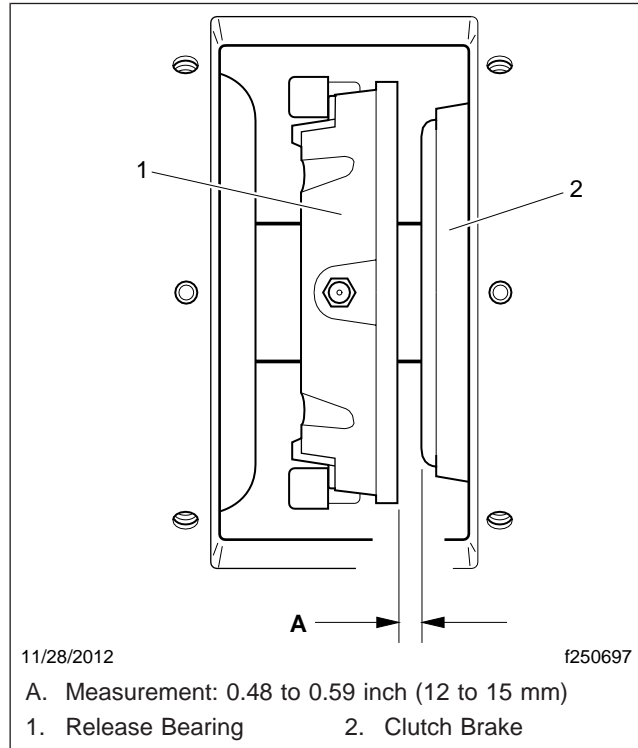
**Fig. 1, Clutch Gap**

1. Park the vehicle on a level surface, shut down the engine, and set the parking brake. Chock the tires.
2. Remove the clutch inspection cover.
3. Measure the gap between the clutch brake and the release bearing. The distance should be between 0.48 and 0.59 inch (12 and 15 mm). See [Fig. 1](#).

*If the distance is less than 0.48 inch (12 mm)*, reset the clutch (see "Resetting the Clutch"). If the problem is fixed, no further work is needed, otherwise continue with the next step.

*If the distance is correct*, install the inspection cover. Tighten the screws 14 to 18 lbf-ft (19 to 24 N-m). Proceed to the next step.

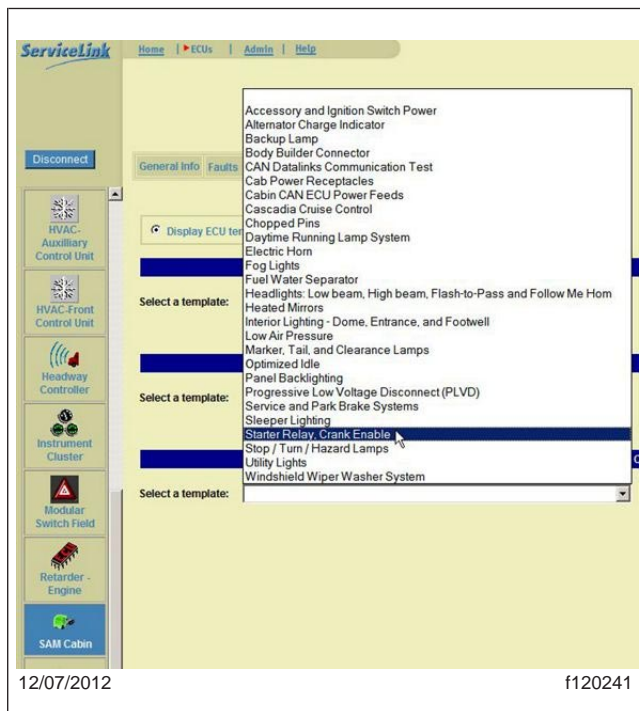
**Fig. 2, ServiceLink Template Menu**

5. Connect the vehicle to the ServiceLink diagnostic tool. Select the SAM Cab ECU, then go to the "Templates" tab and select "Starter Relay, Crank Enable." See [Fig. 2](#).
6. While pushing the pedal to the point of clutch brake squeeze ([Fig. 3](#)), check the SAM Cab Template. Does the actuation of the pedal register? The actuation of the pedal is registered when the "Bottom of Clutch Circuit" indicator turns green and reads "At Bottom," as shown in [Fig. 4](#).

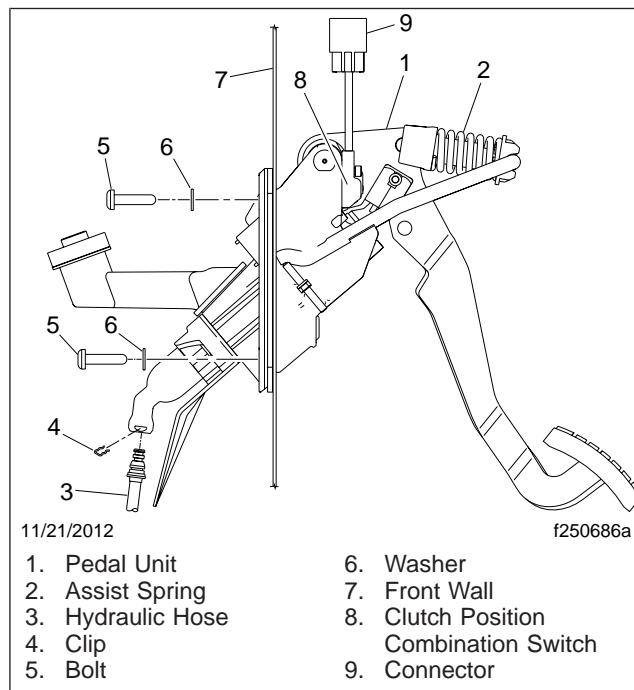
**Fig. 5, Clutch Pedal Assembly**

8. Disconnect the chassis harness from the clutch position combination switch. See [Fig. 5](#).

*If YES*, replace the switch. See *Cascadia Workshop Manual, Section 25.01, Subject 150*.

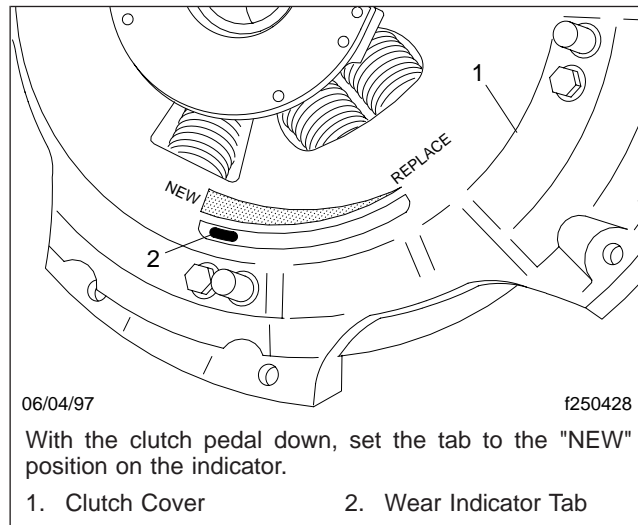
**Fig. 6, Resetting the Wear Indicator Tab**

1. With the parking brake applied and the tires chocked, have an assistant hold the clutch pedal down.
2. With the pedal held down, move the wear indicator tab to the left (NEW) position. See [Fig. 6](#).
3. If the cam does not move, support the transmission and remove the clutch housing bolts. Install 1/2-inch spacers between the clutch housing and the flywheel housing, then, with the clutch pedal held down, attempt to reset the wear indicator tab again.

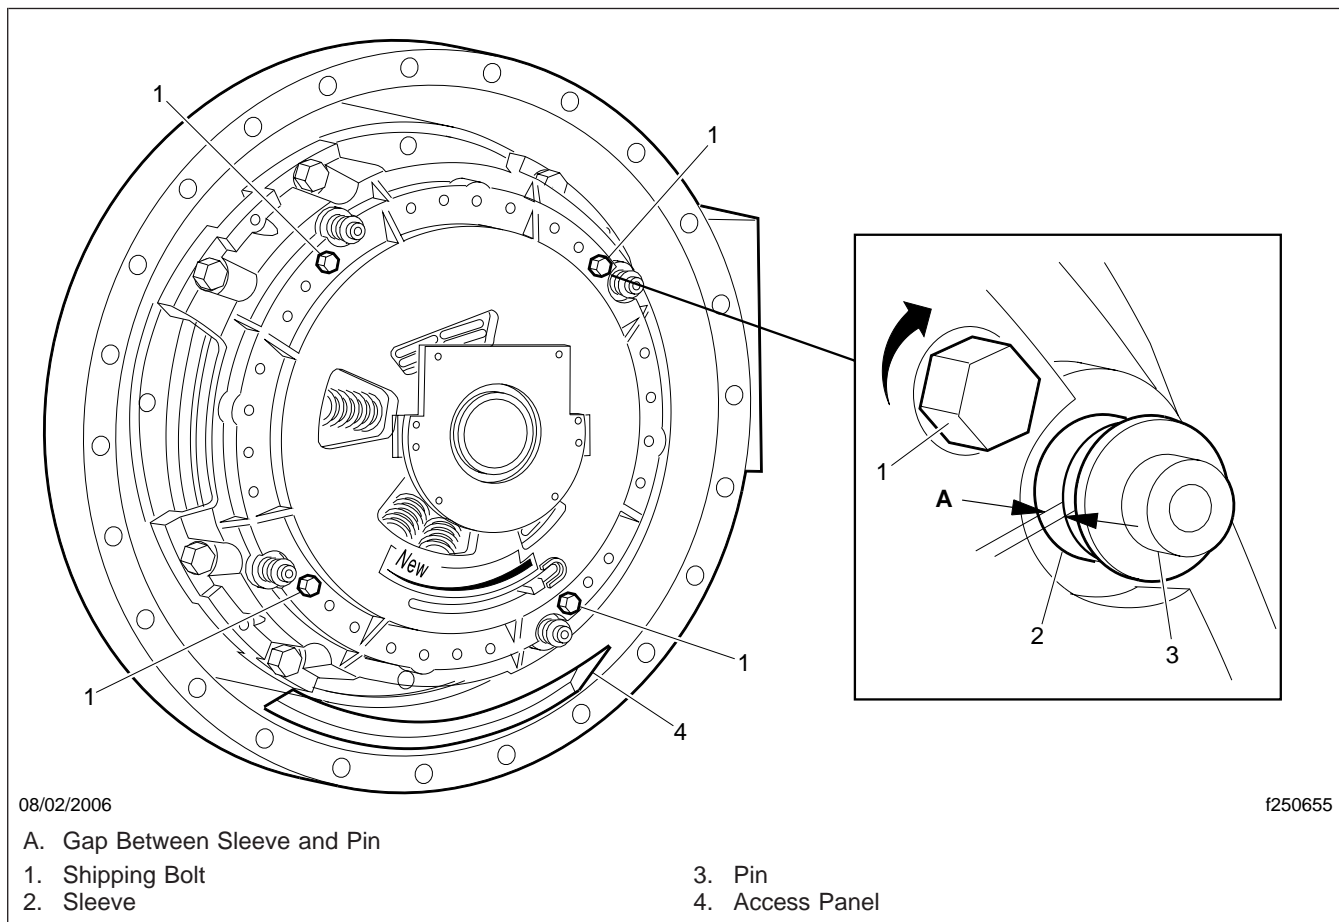
**Fig. 7, Removing the Gap Between Sleeve and Pin**

**IMPORTANT:** To prevent the clutch from returning to an over-adjusted position, the gaps between the sleeves and pins have to be eliminated, as detailed below.

5. Install four shipping bolts (7/16-14 x 1-3/4 UNC) next to the sleeves and pins, as shown in [Fig. 7](#). Tighten the bolts so that the gaps between the sleeves and pins are eliminated.
6. Remove the shipping bolts.
7. Push the clutch pedal down and squeeze the clutch brake five times to reposition the bearing, then recheck the gap between the clutch brake and the release bearing.
8. If the gap returns to less than 0.48 inch (12 mm), replace the clutch assembly.
