**No.: 12 TS-19**  
September 17, 2012

SUBJECT: **Detroit Axle Model 4 FRT Thru-Shaft Snorkel Seal Leak**

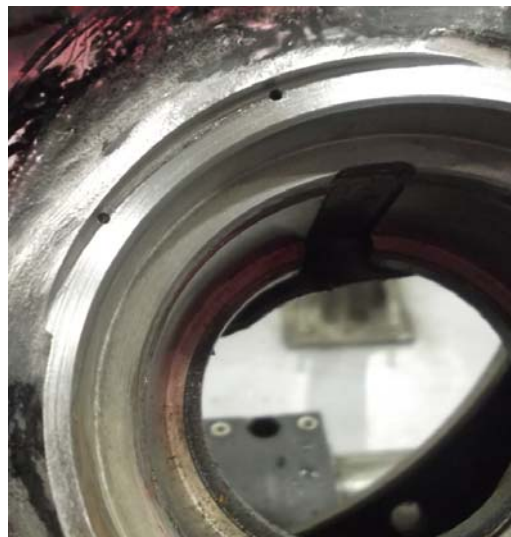
4. Post drilling image.

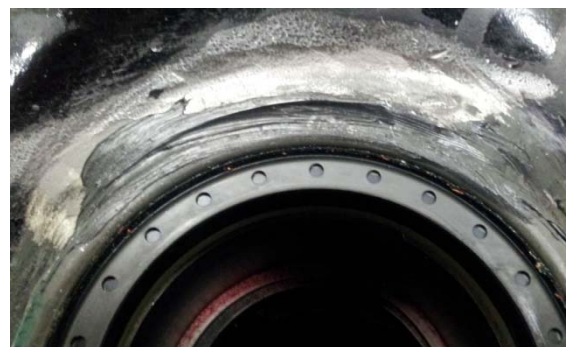
10. Repair completed.
