Bombardier Recreational Products Inc.

Date: December 3, 2012

Re: Model Year 2013 Can-Am™ Spyder - Special Repair Needed at PDI

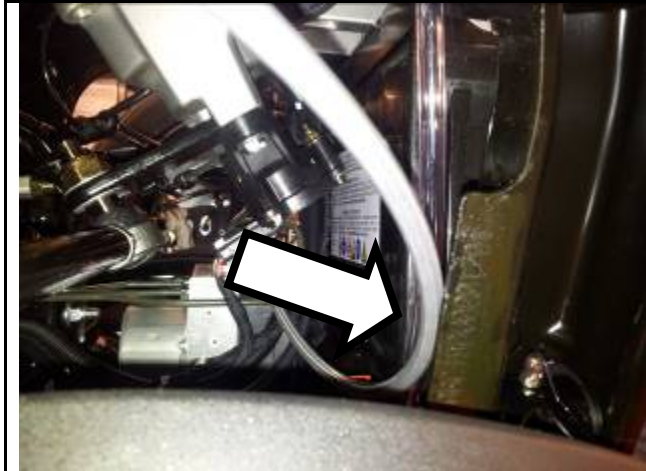
On the RH side of the vehicle, ensure the brake hose is properly secured to the frame; if not, secure it to the frame by inserting the locking tie in the existing hole. Avoid any contact of the brake hose to any sharp edge. Part needed: Locking Tie 368 MM (P/N 293 750 008), qty. 1.

Incorrect Position

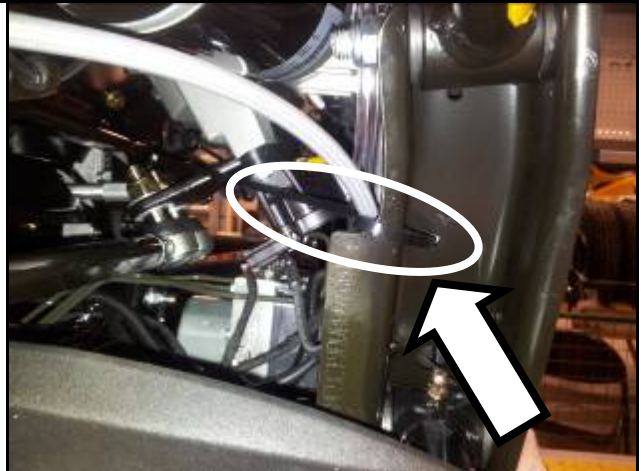
Correct Position With Locking Tie

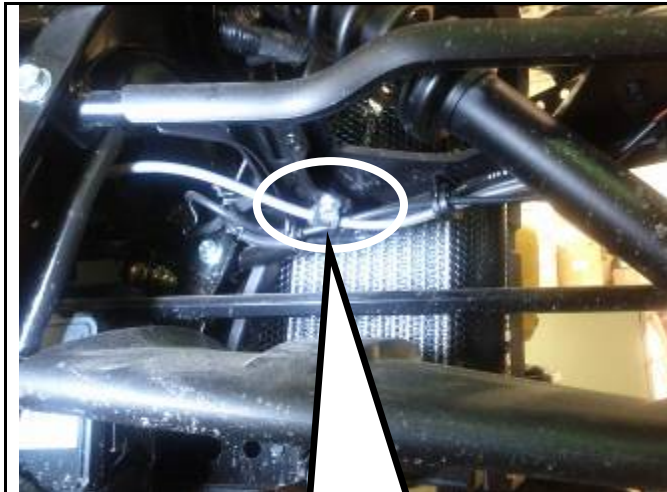
1) Brake hose clamp location

- 1) Ensure the brake hose white mark (the one toward the center of the vehicle) is in contact with the brake hose anchoring bracket rubber piece.
- 2) Ensure there is clearance between the bolt and the brake hose to avoid any contact.

This is the correct brake hose position into the brake hose clamp. If incorrect, loosen the brake hose bracket to relocate the brake hose white mark as shown.

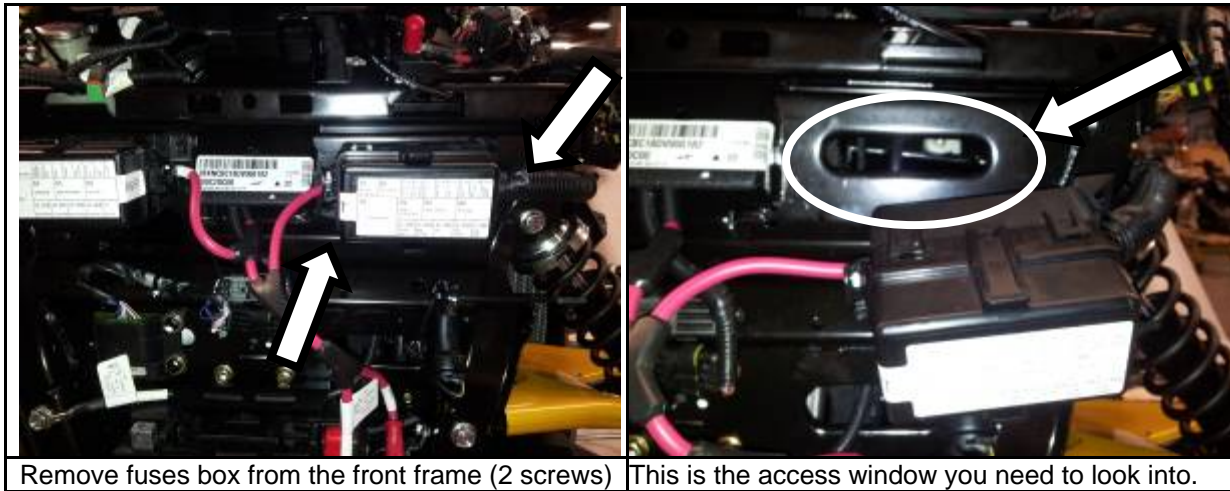
You may see up to 3 wires between the ECM lower anchoring point and the center of the vehicle.

- Red positive cable with corrugated over it
- Regulator/rectifier wires (2) protected by harness tape
- Large black ground cable

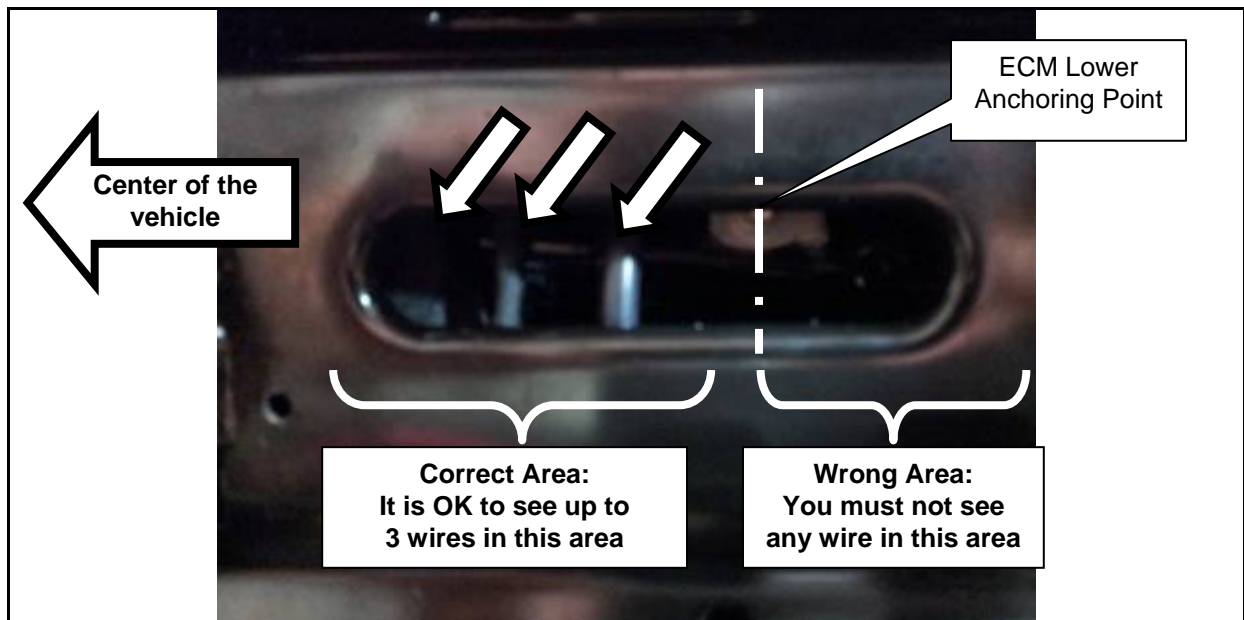
Correct Routing	Wrong Routing
<ul style="list-style-type: none"> • Up to 3 wires are visible in the correct area • Each visible wire can be moved slightly with fingers (side-to-side) 	<ul style="list-style-type: none"> • One or more wire is visible in the Wrong Area • One or more wire can not be moved slightly from side-to-side with fingers (must not feel pinched)
<p>No correction needed: reassemble fuse box</p>	<p>Solution: Reroute wire(s), or replace damaged/pinched wire(s).</p>
