# Authorized Field Change

AFC 12931

**Subject:** Diesel Particulate Filter (DPF) Temperature Sensor Harness Reinstallation

Model: PB105 and PB405, BE and CE Bus

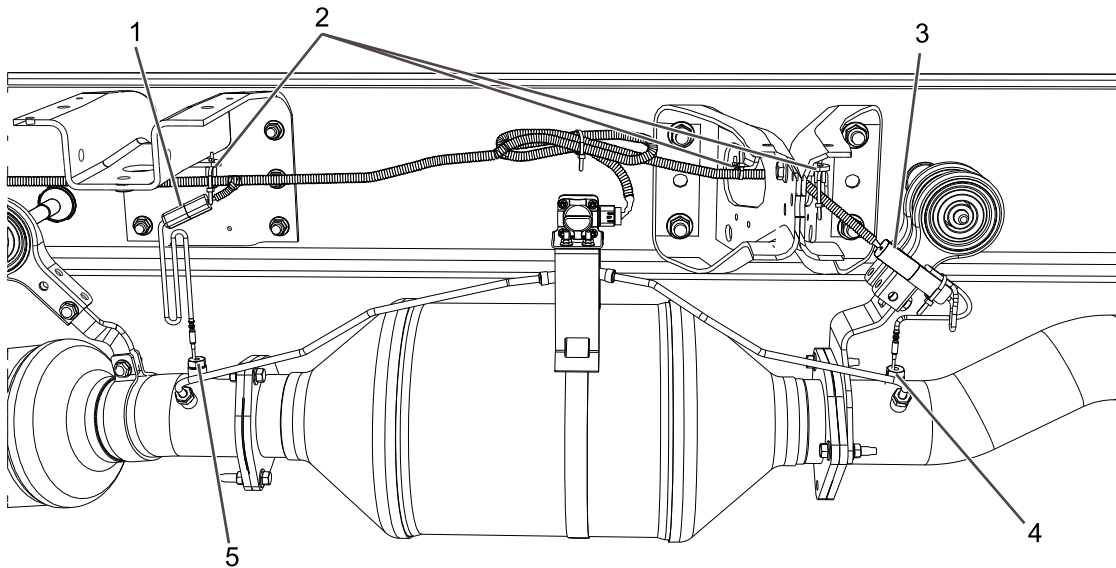
**Figure 1. DPF Harness: Original Installation.**

1. DPF inlet chassis harness connector
2. Tie strap (3)
3. DPF outlet chassis harness connector
4. DPF outlet sensor
5. DPF inlet sensor

1. Park vehicle on flat surface, shift transmission into park or neutral, and set parking brake.
2. Install wheel chocks.
3. Move under vehicle at DPF assembly and disconnect DPF outlet temperature sensor connector (Figure 1, Item 3).
4. Exit from under vehicle and enter unit. Open ServiceMaxx™ and turn ignition key ON.
  - a. If ServiceMaxx™ shows DTC SPN 3246 FMI 3 - DPFOT signal Out of Range HIGH and DPF Outlet Temp error, turn ignition key OFF and remove key to prevent unauthorized movement of vehicle. Reconnect DPF outlet temperature sensor connector (Figure 1, Item 3), enter unit, and turn ignition key ON. DTCs will show as previously active. Clear codes and take no further action.
  - b. If ServiceMaxx™ shows DTC SPN 3243 FMI 3 - DPFIT signal Out of Range HIGH and DPF Inlet Temp error, turn ignition key OFF and continue with this procedure.

5. Remove existing tie straps (Figure 1, Item 2) from right-side frame rail at DPF inlet sensor connector, right-side frame rail forward of cross member at rear of DPF, and right-side frame rail rear of cross member above DPF outlet sensor.
6. Reroute DPF outlet chassis harness connector (Figure 1, Item 3) through right-side chassis cross member toward DPF inlet temperature sensor (Figure 1, Item 5).
7. Disconnect DPF inlet temperature sensor (Figure 1, Item 5) from chassis harness connector (Figure 1, Item 1) and connect DPF inlet sensor connector to DPF outlet chassis harness connector (Figure 1, Item 3).

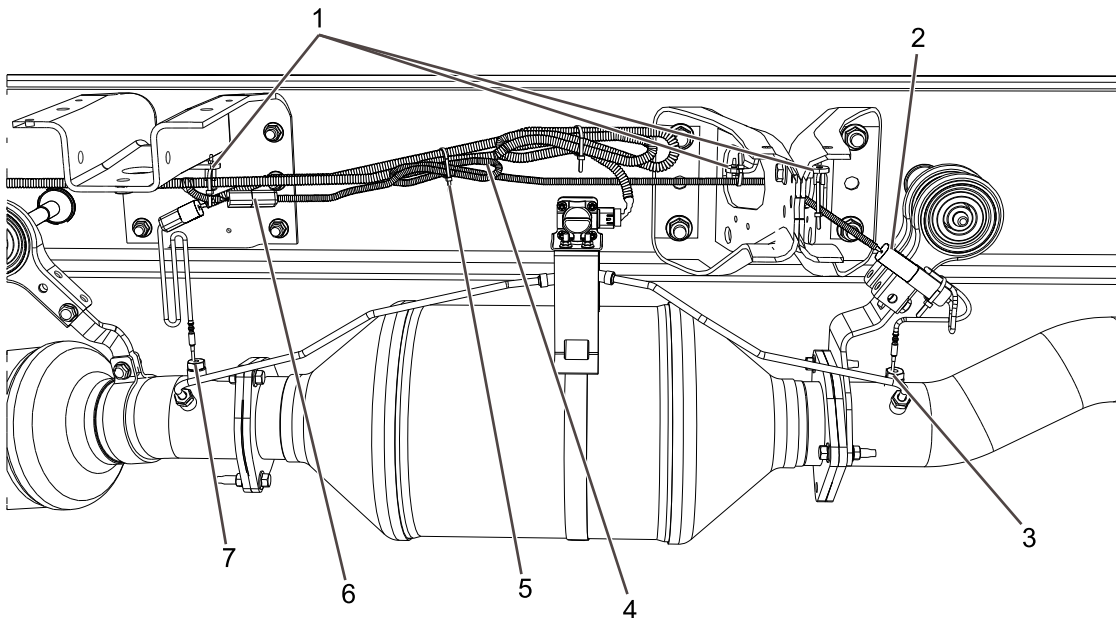
**Figure 2. DPF Harness: Modified Installation.**

1. Tie strap (3)
2. DPF outlet sensor connector
3. DPF outlet sensor
4. Jumper harness
5. Tie strap
6. DPF inlet sensor connector
7. DPF inlet sensor

8. Connect jumper harness (Figure 2, Item 4) to DPF inlet chassis harness connector (Figure 2, Item 6).
9. Route jumper harness (Figure 2, Item 6) through right-side chassis cross member to DPF outlet sensor (Figure 2, Item 3).

10. Connect jumper harness connector (Figure 2, Item 2) to DPF outlet temperature sensor (Figure 2, Item 3).
11. Install tie strap securing jumper harness at right-side frame rail rear of cross member above DPF outlet sensor (Figure 2, Item 1). Position jumper harness connector (Figure 2, Item 2) to allow adequate slack and tighten tie strap.

12. Install tie strap securing jumper harness at right-side frame rail forward of cross member above DPF assembly (Figure 2, Item 1) and tighten tie strap.

13. Install tie strap at DPF inlet sensor connector (Figure 2, Item 1). Adjust all harnesses to ensure appropriate slack forward of this clipping point and to sensor. Tighten tie strap.

14. Remaining jumper harness and chassis harness must be bundled and clipped using an additional tie strap (Figure 2, Item 5).
