Countries:	CANADA, UNITED STATES, MEXICO	Document ID:	IK0800366
Availability:	ISIS, FleetISIS	Revision:	5
Major System:	ELECTRICAL SYSTEM	Created:	5/9/2012
Current Language:	English	Last Modified:	11/15/2012
Other Languages:	NONE	Author:	Eddie Panozzo
Viewed:	922

Title: Power Windows randomly stop

Applies To: Multiplexed Power Windows

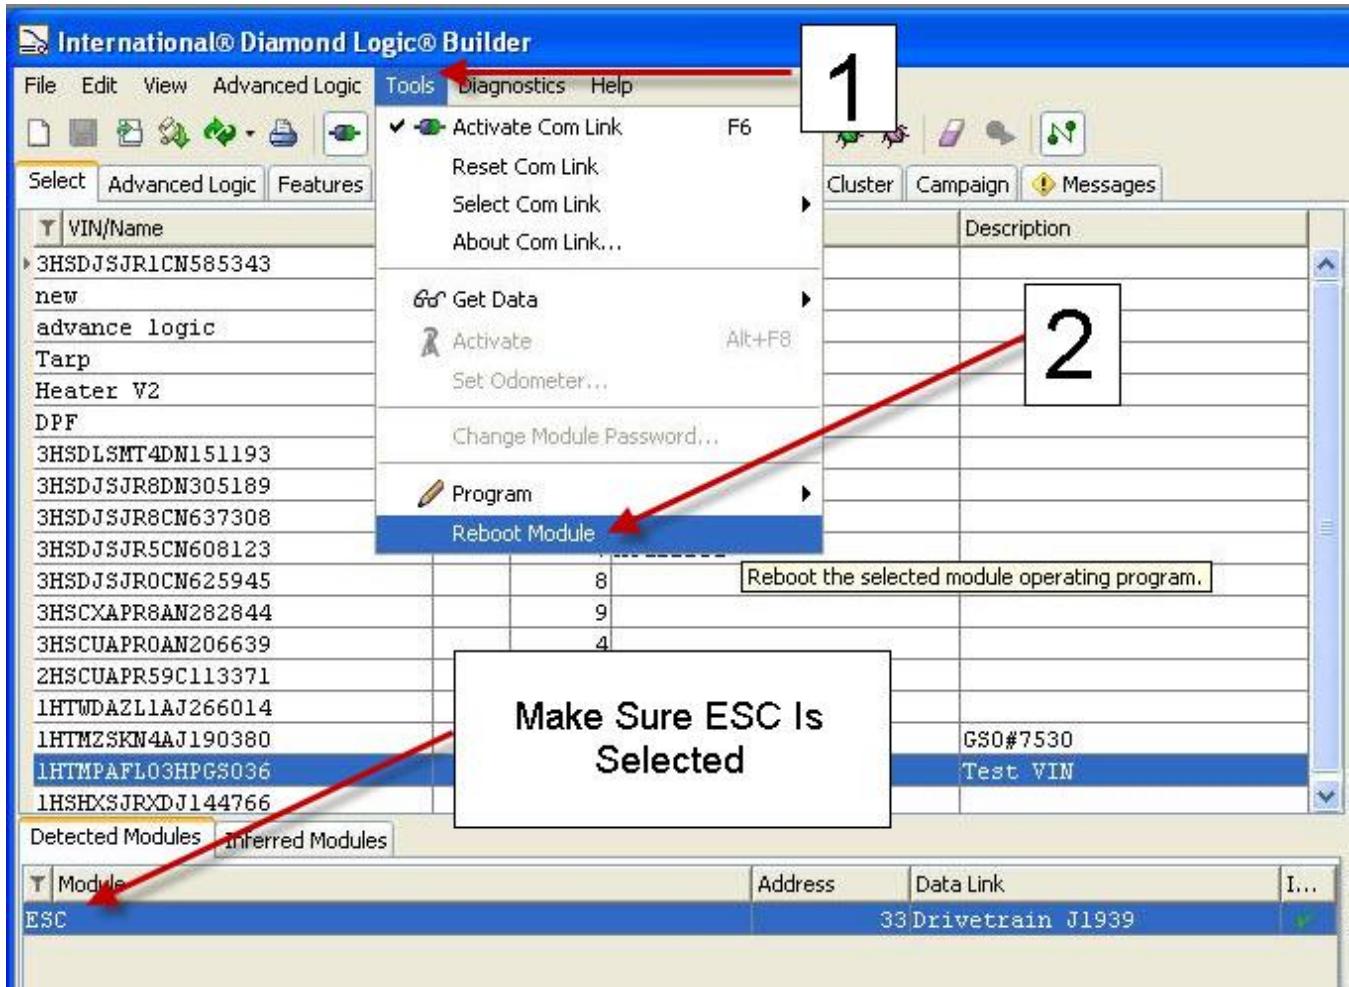
Windows randomly stop moving. This issue is caused by the doorpod not receiving a message from BC in time. The doorpods then go to sleep for 1 to 5 seconds.

For the time being, if you receive a vehicle with this complaint, please reboot the body controller using DLB and recheck operation. If the vehicle is now working correctly, then return the vehicle to the customer. This will not repair the vehicle, but will reset the system. Engineering is working on the resolution. Also, please refrain from opening a case file if this resolves the issue.
