| <b>Countries:</b> | CANADA,<br>UNITED STATES | <b>Document ID:</b> | IK1200709 |

**Title:** EGR Bellows Tube

**Applies To:** MaxxForce 2010 13L and 11L Engines ESN: 4100000 and UP

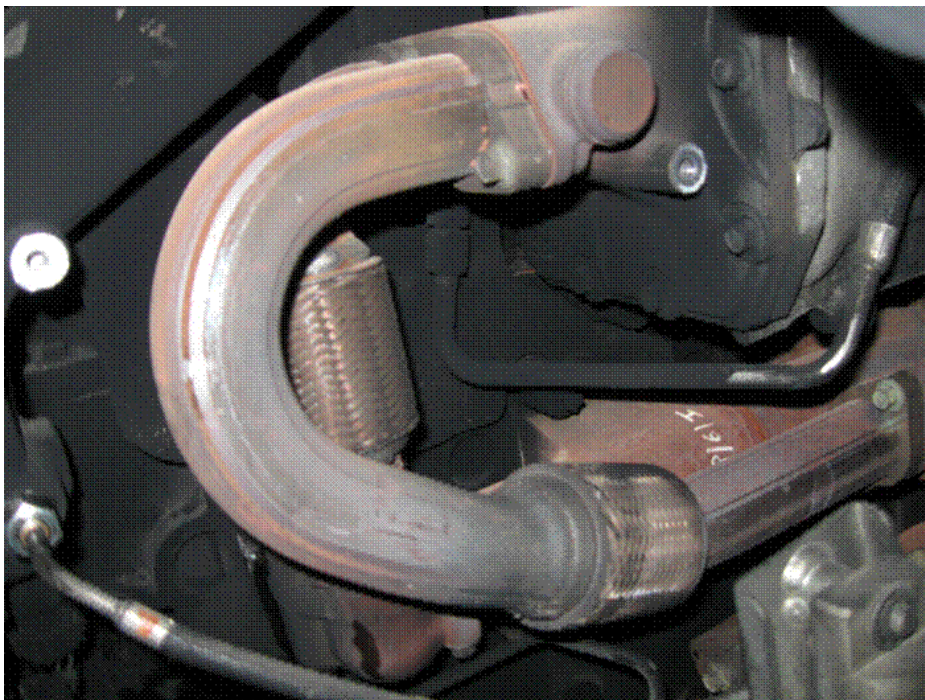
Some field vehicles have been found with EGR hot side inner (3005782C3) and outer (3005416C3) bellows cracked.

If a fracture or exhaust leak is found at the EGR hot side inner (3005782C3) or outer (3005416C3) bellow tube replace both the outer and inner EGR hot side bellow tubes. The kit number for the EGR hot side inner is 3007671C95 and EGR hot side outer is 3007670C95. **Do not use part 3005782C3 for the EGR hot side inner tube or 3005416C3 EGR hot side outer tube for the replacement.** Part number 3005782C3 has been replaced with 3005782C4 and part number 3005416C3 has been replaced with 3005416C4.

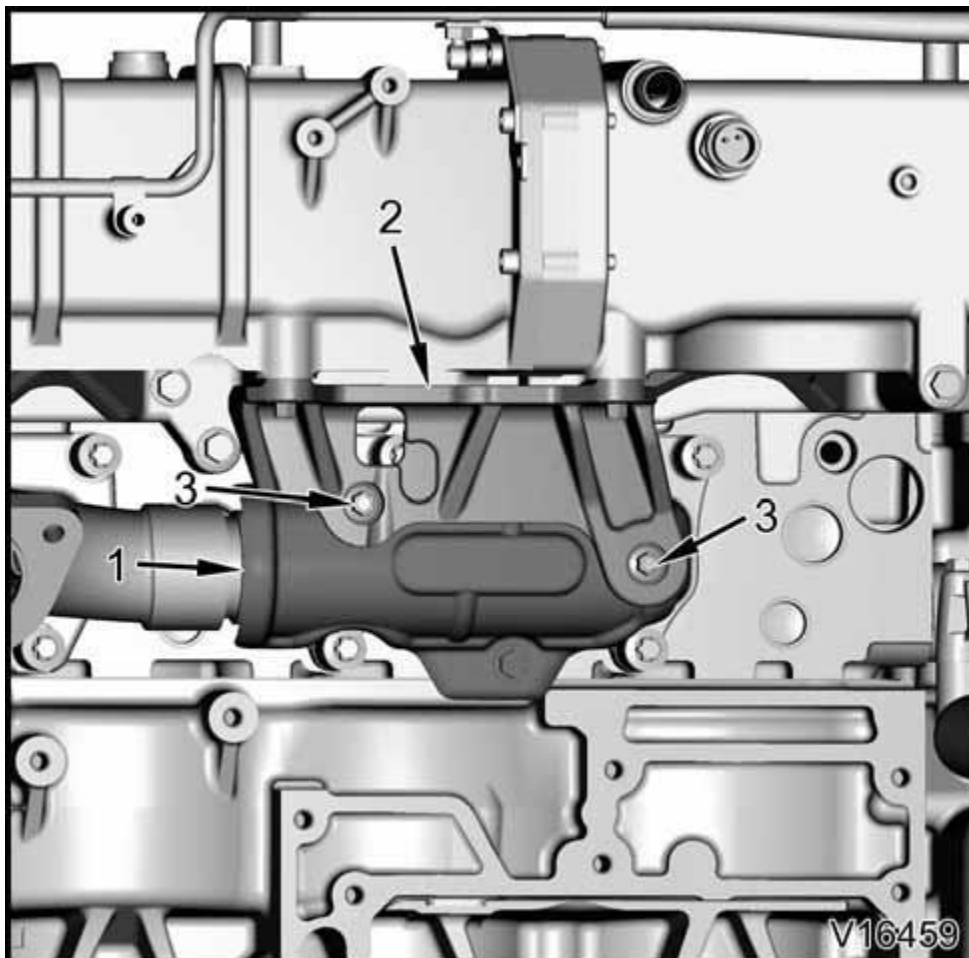
**Figure A**

1. Heat protection shield (at front exhaust manifold)
2. EGR cooler bracket
3. M8 x 25 heat-resistant bolt (2)

1. Inspect the EGR hot side inner (3005782C3) and outer (3005416C3) bellow tubes for cracks or exhaust leaks.
  2. Check the integrity of engine & chassis harness in the surrounding area. You will look for melted: split loom, connectors, and/or wire insulation.
  3. Lookup case file history. If complete or low temperature side EGR cooler has been replaced you will inspect for missing or loose of bolts in the "L" shaped bracket (Reference Figure A).
- A. The 2 vertical bolts, (up & down) are **OFTEN** found to be never re-installed or are left loose in the field after complete or partial EGR Cooler replacement. These **MUST** be installed. Your parts department will find you these vertical bolts through the parts system or local supplier.
