# Authorized Field Change

AFC 12930

**Subject:** Air Control Valve (ACV) Connector with Plugs Installed Backwards in Empty Connector Cavities

Model: LoneStar®, PayStar®, WorkStar®, TranStar®, and ProStar®; Continental FD Mixer built 24 September 2012

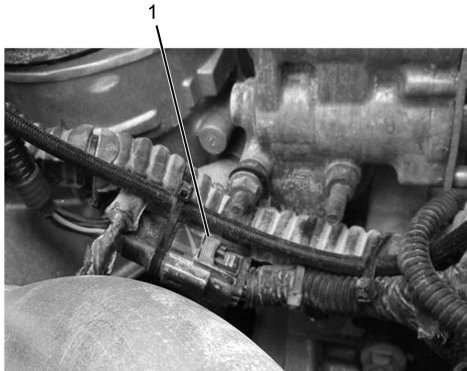
**Figure 1. Updated ACV Connector.**

4. Locate updated ACV connector (Figure 1, Item 1) secured to Coolant Control Valve (CCV) near front on passenger side of engine.

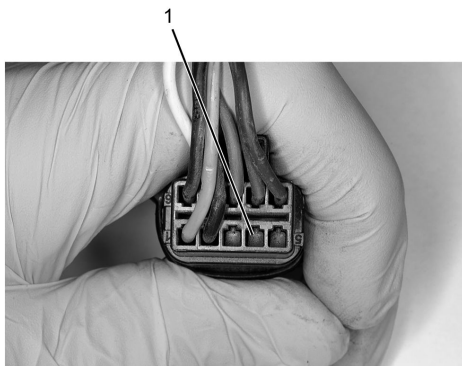
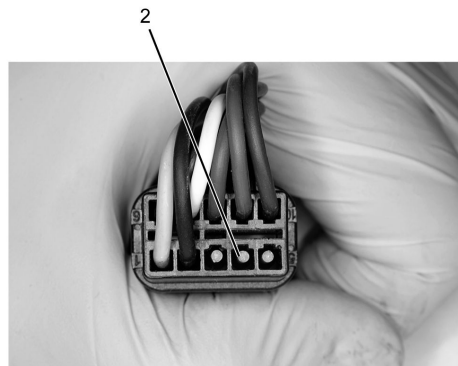
**Figure 2. ACV Connector Plugs.**

This AFC applies to vehicles with Air Control Valve (ACV) 3015646C91. Some ACV connectors were produced with plugs installed backwards in empty connector cavities. This could permit water intrusion, which could short the terminals. This may lead to ACV failure or EGR cooler plugging. This repair will involve reinstalling the plugs in the correct orientation to ensure the connector is tightly sealed.

1. ACV connector
5. Unlatch red lock button and disconnect ACV connector.
6. Inspect plugs in ACV connector to determine if they have been inserted backwards (Figure 2, Item 1). If installed incorrectly, plugs must be reinstalled to proper orientation (Figure 2, Item 2) following this procedure.

1. Incorrectly installed plugs
2. Correctly installed plugs

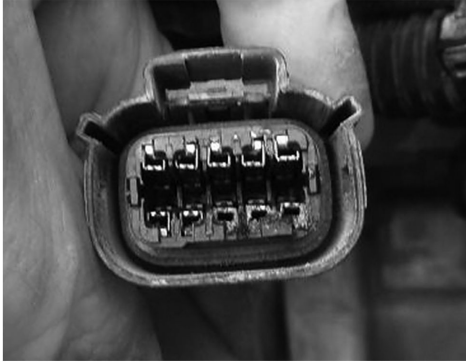
**Figure 3. Engine Harness Side.**

**NOTE:** Incorrectly installed plugs may cause corrosion due to moisture intrusion (Figures 3 and 4). If ACV connector is corroded or damaged, do not attempt repair. Create Technical Parts Case which references AFC 12930, including part description and quantity needed.
