Authorized Field Change

AFC 12942

Subject: Fan Clutch Harness Routing Repair

Model: ProStar® and TranStar®

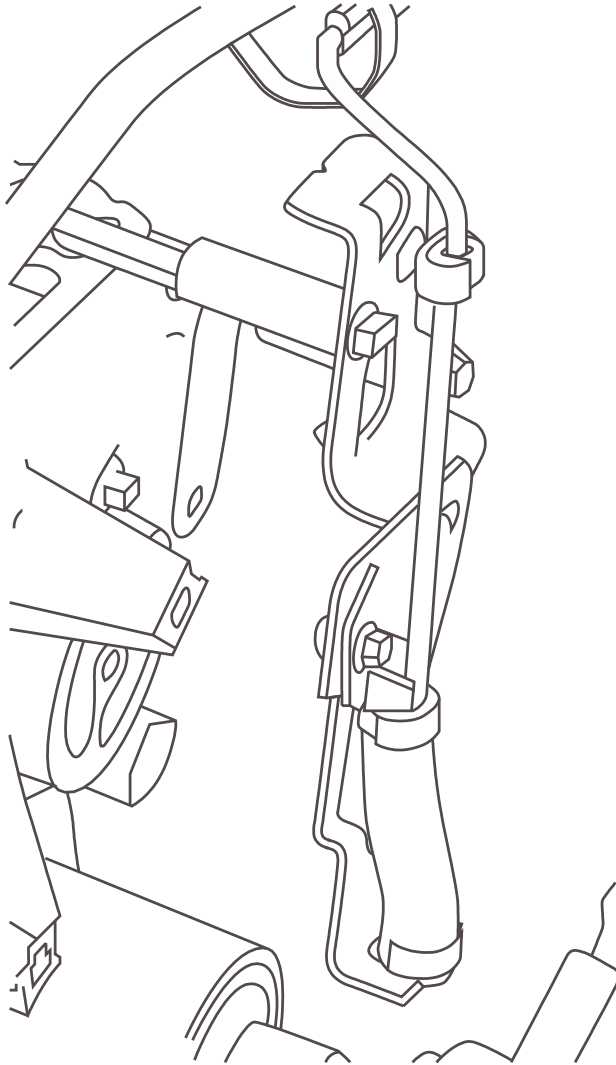
Figure 1. Fan Clutch Harness Correctly Installed.

5. If harness is routed correctly (refer to Figure 1) and harness is not rubbing against edge of fan clutch harness bracket, no rework is required.

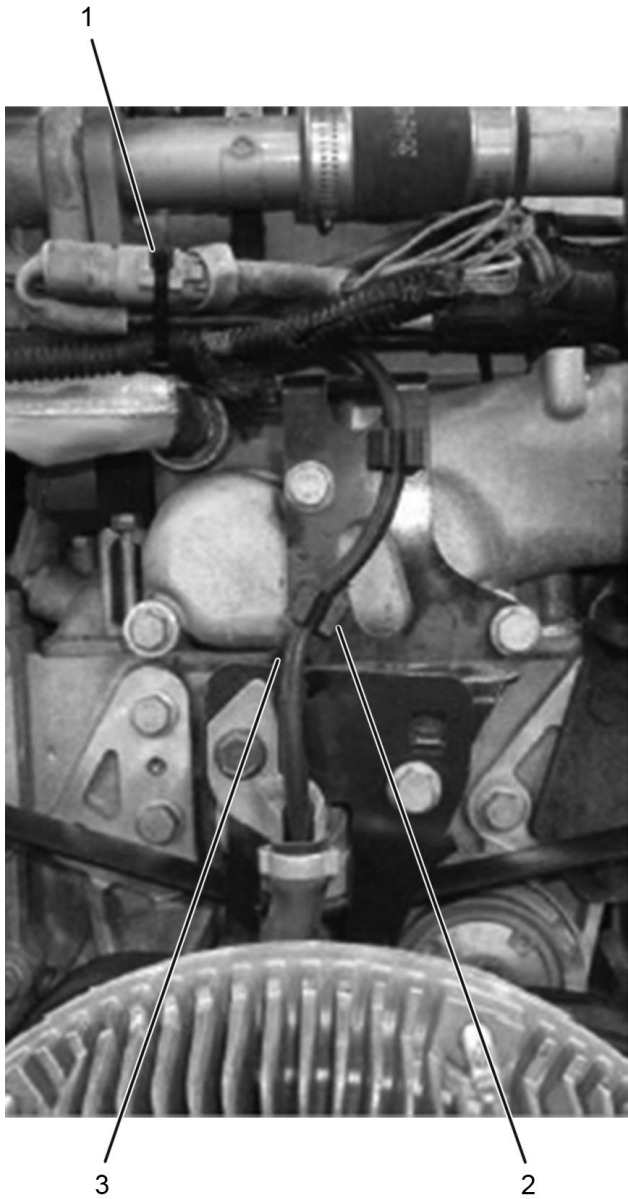
Figure 2. Fan Clutch Harness Incorrectly Installed.

The fan clutch harness can rub on the fan wiring harness bracket and cause intermittent fault codes. Some of the symptoms can include: Low Power, Erratic Fan Engagement, No Fan Engagement, or a VREF 4 DTC code. This repair will require rerouting the harness, inspecting the harness for abrasion, and repairing the harness, if required.

1. Tie strap
2. Lower fir tree push mount cable tie
3. Abrasion point

6. If harness is routed incorrectly (refer to Figure 2), follow remaining steps of this procedure.

7. Remove tie strap (Figure 2, Item 1) securing fan clutch harness connector to engine harness. Discard tie strap.
8. Gently pull fan clutch harness toward fan clutch.

9. Remove lower fir tree push mount cable tie (Figure 2, Item 2) from fan clutch harness. Discard fir tree push mount cable tie.
10. Inspect fan clutch harness for damage:

- a. If no damage is observed, make sure there is clearance between fan clutch harness and bracket.
 1. Gently pull fan clutch harness upward to gain clearance from bracket. Install new tie strap (Figure 2, Item 1) securing fan clutch harness to engine harness where previously removed.

- b. If damage is observed, repair harness as follows:
 1. If only outer protective sheath or outer sheath and part of insulation on wire harness is damaged, install heat shrink over damaged area.

2. If copper is showing on any wires, fan clutch harness must be repaired following IK0800269.
 - A. When fan clutch harness repair is complete, heat shrink must be installed over harness where sheathing was located.

3. Insert fan clutch harness into top fir tree push mount cable tie.
 4. Gently pull fan clutch harness upward to eliminate slack in harness.
 5. Verify that there is clearance between fan clutch harness and fan clutch harness bracket (Figure 2, Item 3).

6. Install new tie strap (Figure 2, Item 1) securing fan clutch harness to engine harness where previously removed.
11. Close hood.
12. Remove wheel chocks.
