**Countries:** CANADA, UNITED STATES, MEXICO **Document ID:** IK0700051  
**Availability:** ISIS, FleetISIS **Revision:** 1  
**Major System:** EXHAUST **Created:** 12/20/2012  
**Current Language:** English **Last Modified:** 12/21/2012  
**Other Languages:** NONE **Author:** Charles Sun  
**Viewed:** 224

**Title:** Rear Exhaust Manifold Leak**Applies To:** MaxxForce® DT, 9 and 10 (2010 M.Y.)

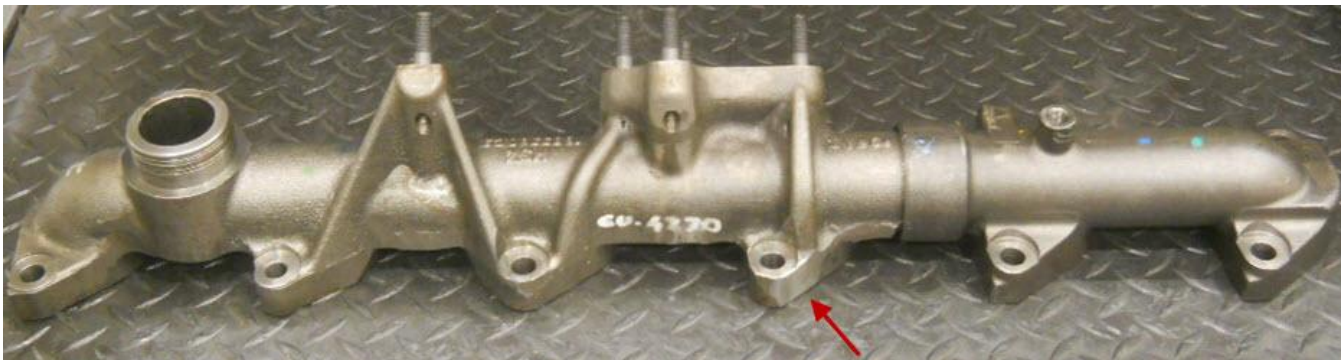
When truck is serviced for rear exhaust manifold leak, check for presence of a square shaped ear at rear of exhaust manifold. Current production exhaust manifolds have been modified to remove ear and existing inventories had these ears machined off.

Current Manifold

Revised Manifold
