| <b>Countries:</b> | CANADA, UNITED STATES, MEXICO | <b>Document ID:</b> | IK1200013 |

**Title:** Engine starts when cold but not when it warms up. Diagnosing an Injection Control Pressure (ICP) system leak on the VT365 and VT275 engine DTC 333 335

**Applies To:** Model: International VT-365 and VT-275 2004-2006 Engines

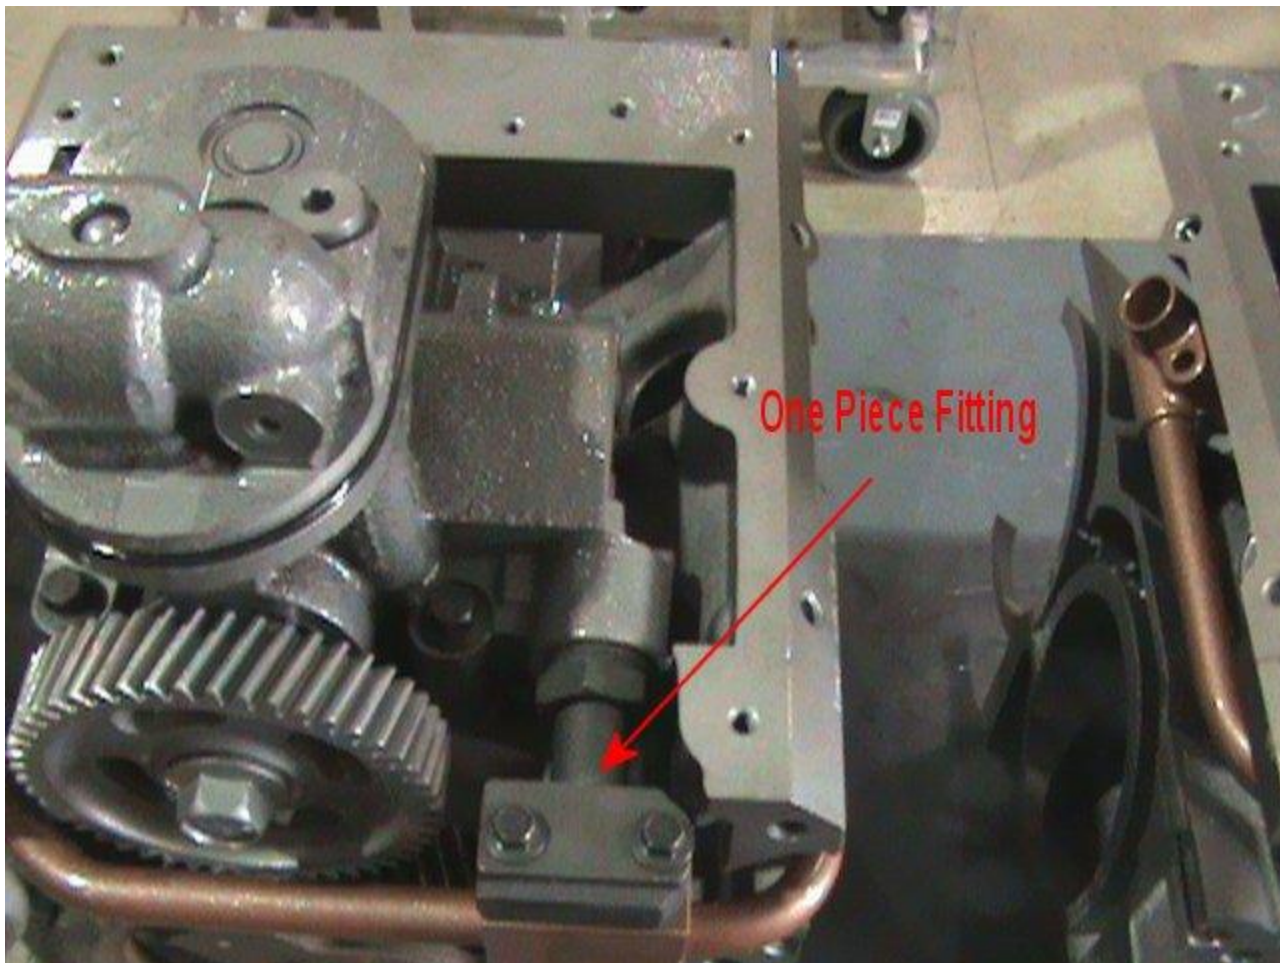
When replacing the Snap to Connect Fitting (STC) use the New One Piece Fitting Kit (OPF) **1879930C91**

The OPF replaces the STC fitting with bracket. Do not reuse bolts.
