Countries:	AUSTRALIA, CANADA, UNITED STATES, MEXICO	Document ID:	IK1600166
Availability:	ISIS, FleetSIS	Revision:	2
Major System:	CAB / SLEEPER / HOOD	Created:	11/16/2012
Current Language:	English	Last Modified:	11/16/2012
Other Languages:	NONE	Author:	Patrick Gotschall
Viewed:	149

Title: Water leaks through Cab Cowl pass-through connections

Applies To: TerraStar, DuraStar, WorkStar, TranStar, ProStar, LoneStar

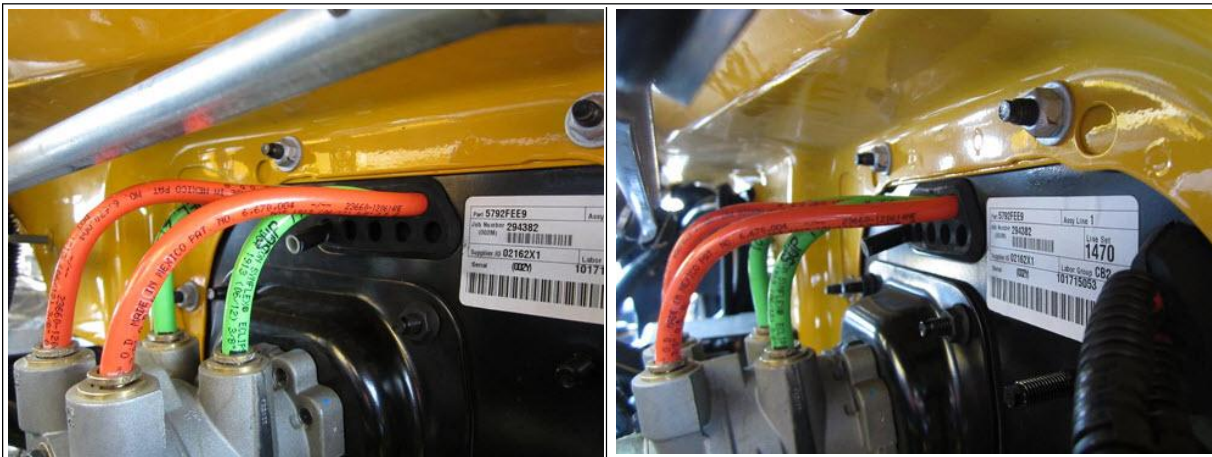
Exterior view of one of the Grommets in question

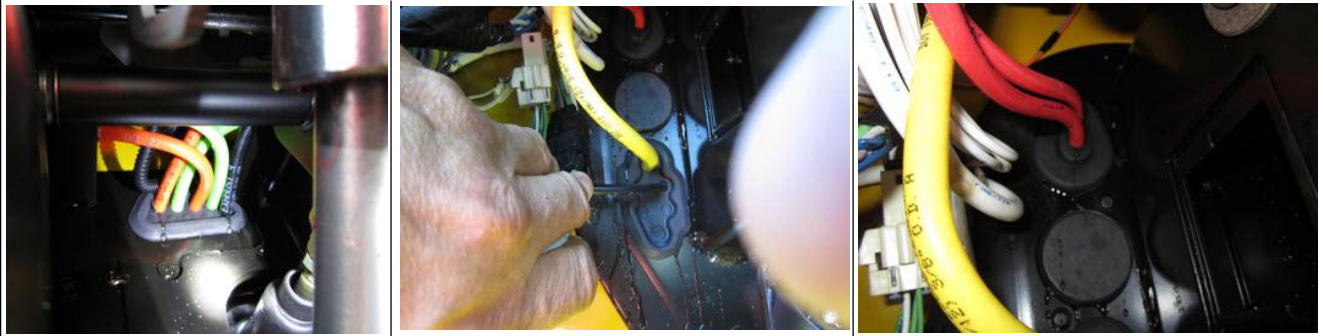
Interior view of one of the Grommets in question

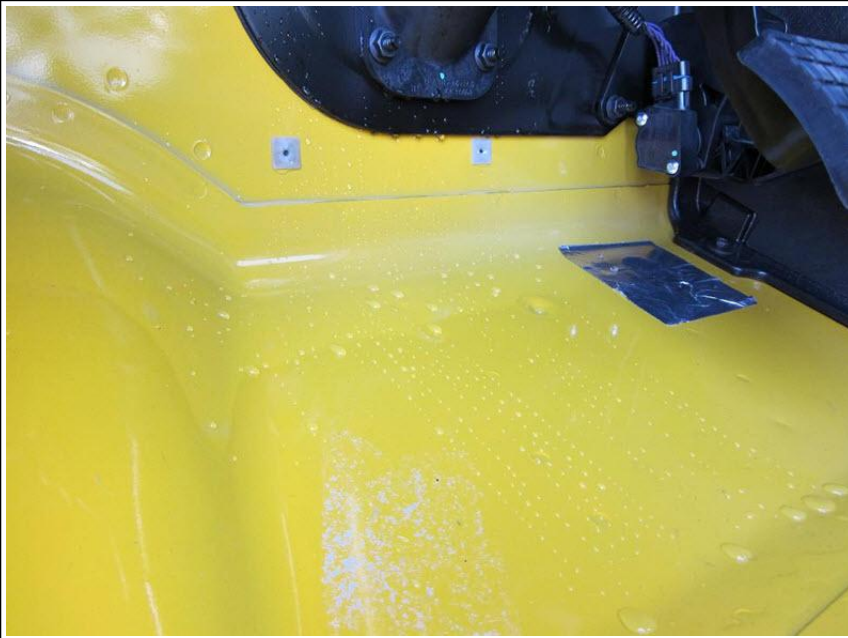
Evidence of the leaks on the floor of a new truck

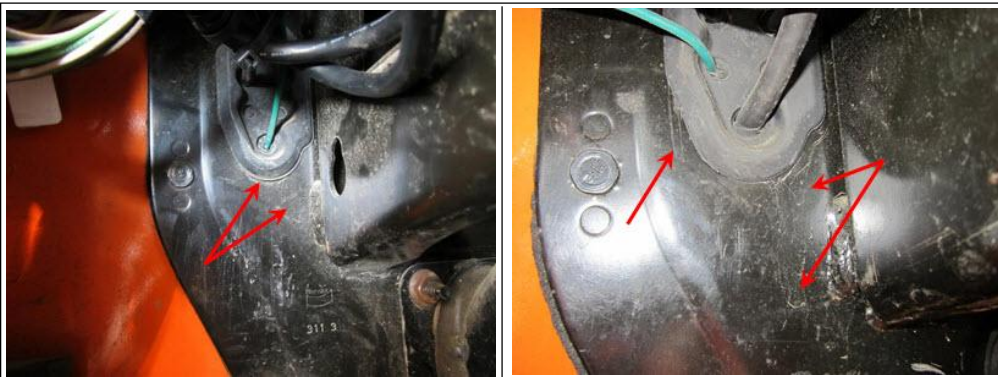
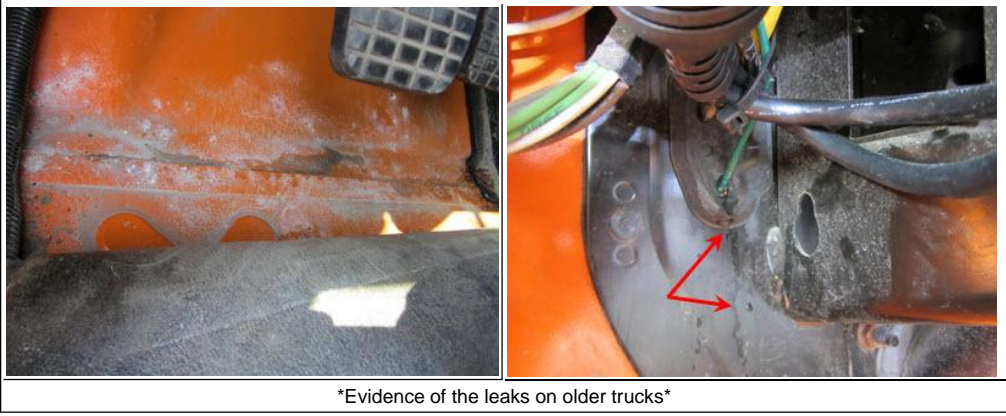
Evidence of the leaks on older trucks
