## TITLE: CAC TUBE SUPPORT IMPROVEMENT – FIX AS FAIL Prevost vehicles

On the vehicles affected by this bulletin, improvement of a Charge Air Cooler tube support is required. *This is a “Fix as Fail” bulletin, repair only the vehicles showing a cracked CAC tube.*

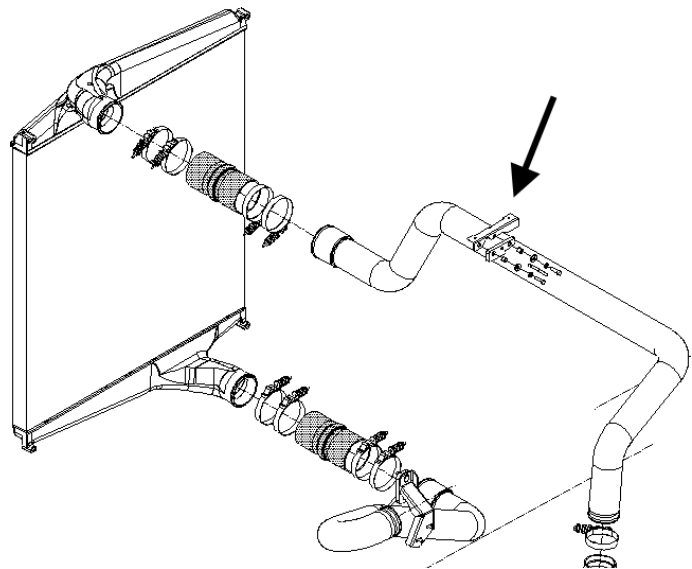
Locate this support along the top charge air cooler line in the engine compartment.
