# ECM Calibration: Enhancement to Shifting Performance

YEAR(S)	MODEL(S)	ADDITIONAL INFORMATION
2008 – 2011	Land Cruiser	Transmission(s): 6AT VDS(s): HY05J, HY7AJ

Some 2008 – 2011 model year Land Cruiser vehicles may exhibit a harsh shift on acceleration below 20 mph during the 2-1 downshift. The Engine Control Module/ECM (SAE term: Powertrain Control Module/PCM) calibration has been revised. Use the following repair procedure to address this condition.

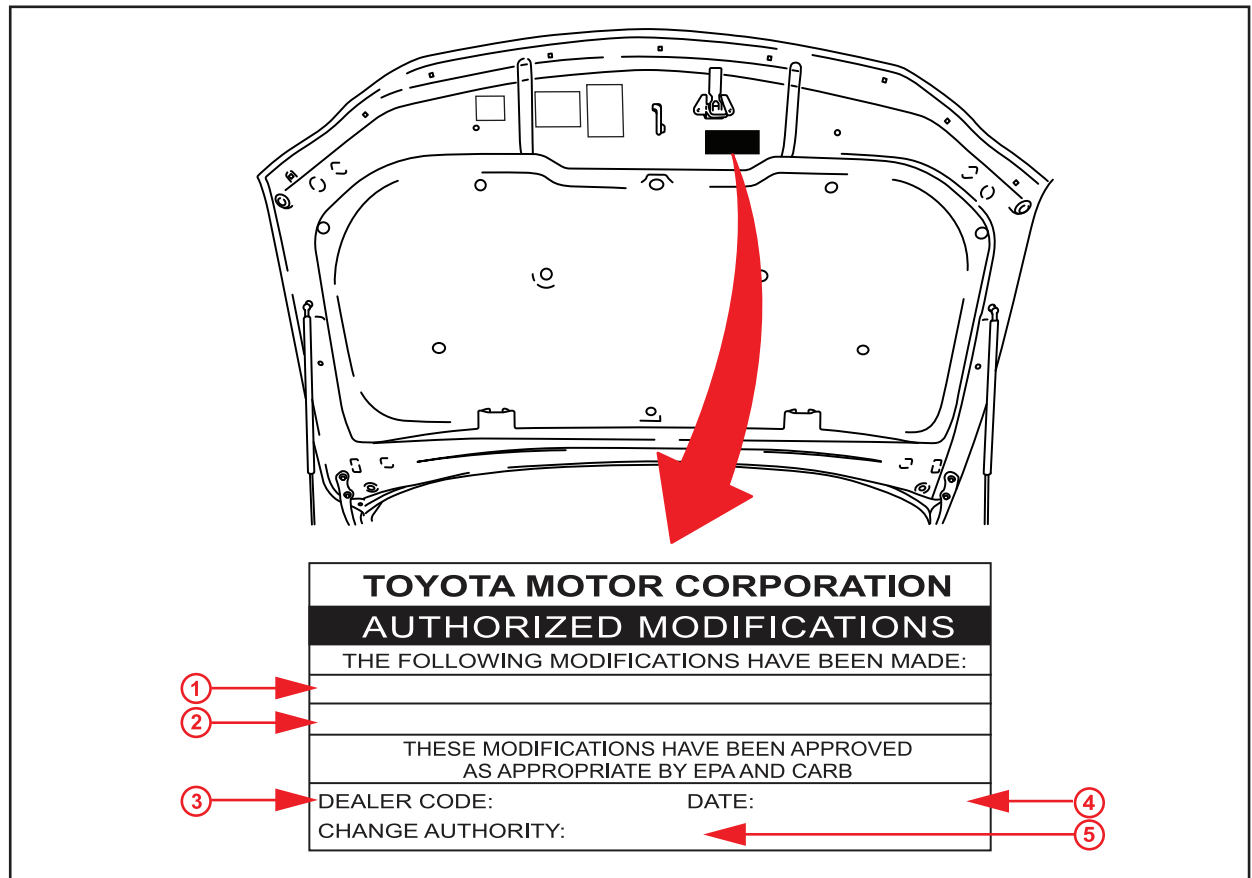
Figure 1. Location of Authorized Modifications Label on 2008 – 2011 Land Cruiser

2. Check for the Authorized Modifications Label affixed to the vehicle in the location shown in Figure 1. Confirm if the ECM (PCM) calibration has been updated. If the calibration ID listed is NOT the latest ECM (PCM) calibration — go to step 3.

4. Install the Authorized Modifications Label.
  - A. Using a permanent marker, enter the following information on the label:
    - ECM part number [*Refer to the **Parts Information** section for the **CURRENT PART NUMBER***]
    - Calibration ID(s) [*Refer to the **Calibration Identification Chart** for the **NEW CALIBRATION ID***]
    - Dealer Code
    - Repair Date
    - Change Authority [***This bulletin number***]
  - B. Affix the Authorized Modifications Label to the vehicle at the location shown in Figure 1. The Authorized Modifications Label is available through the MDC, P/N 00451-00001-LBL.
5. Test drive the vehicle and perform transmission initialization.
