# Excessive Wind Noise from Moon Roof when Open

## Applicability

| YEAR(S) | MODEL(S) | ADDITIONAL INFORMATION |
|---|---|---|
| 2011 – 2012 | tC | |

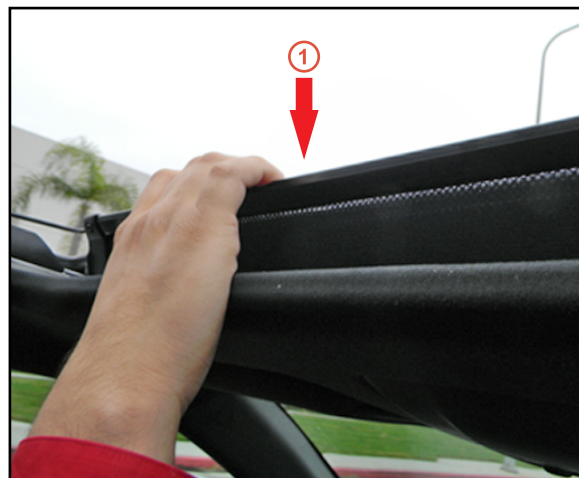
Figure 1.

- Confirm vehicle has excessive wind noise while driving at 45 mph with the moon roof in the "Full Open" position. If excessive wind noise is present, lower the fabric wind deflector ~20 mm (0.75 in.).
  - If wind noise decreases, proceed to step 2.
  - If wind noise does NOT decrease, this bulletin does not apply.
