# MIL "ON" DTC P1235

**Service Category** Engine/Hybrid System

**Section** Engine Control

## Introduction

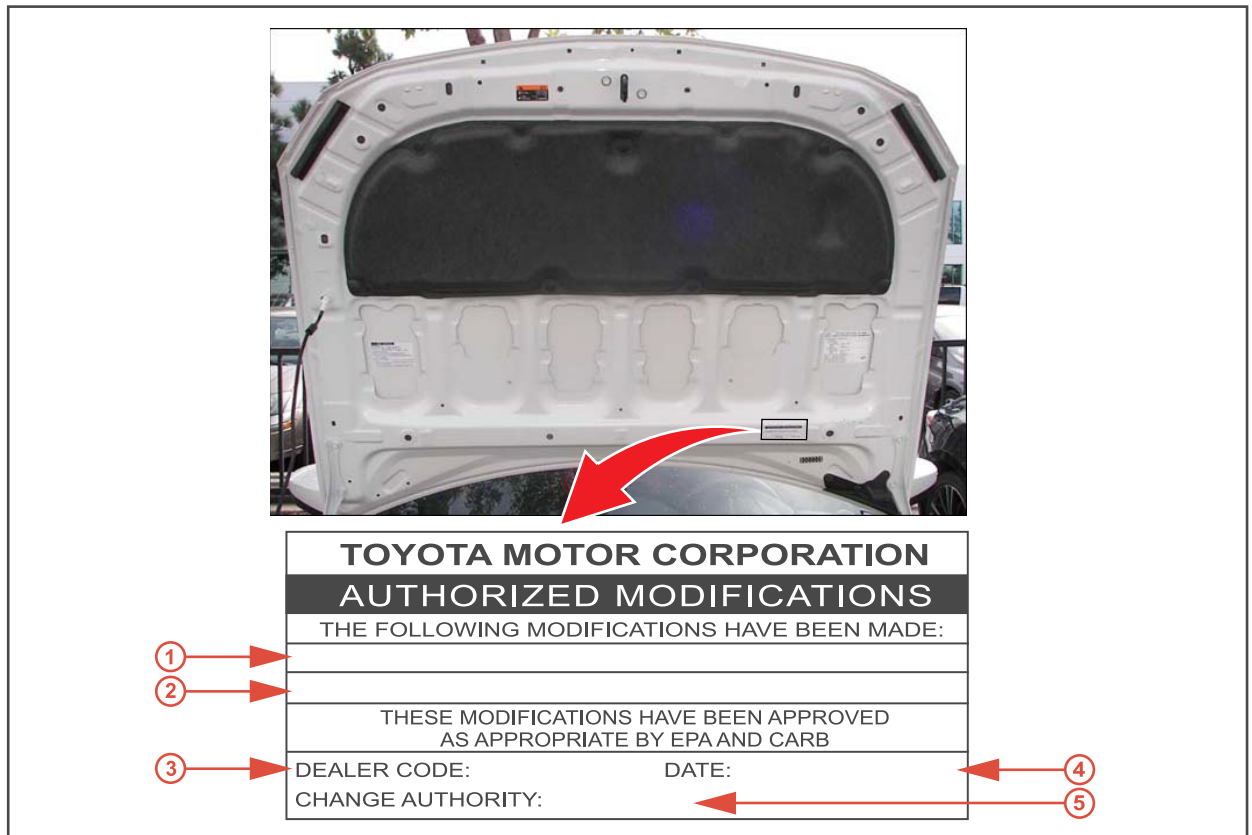
**Figure 1. Location of Authorized Modifications Label on 2013 FR-S**

1. Confirm DTC P1235 is set.
2. Check for the Authorized Modifications Label affixed to the vehicle in the location shown in Figure 1. Confirm if the ECM (PCM) calibration has been updated. If the calibration ID listed is NOT the latest ECM (PCM) calibration — go to step 3.

- Install the Authorized Modifications Label.
  - Using a permanent marker, enter the following information on the label:
    - ECM part number [Refer to the **Parts Information** section for the **CURRENT PART NUMBER**]
    - Calibration ID(s) [Refer to the **Calibration Identification Chart** for the **NEW CALIBRATION ID**]
    - Dealer Code
    - Repair Date
    - Change Authority [**This bulletin number**]
  - Affix the Authorized Modifications Label to the vehicle at the location shown in Figure 1. The Authorized Modifications Label is available through the MDC, P/N 00451-00001-LBL.
- Start the engine and warm it up to normal operating temperature and test drive to confirm proper vehicle operation.
