ECM Calibration: Enhancement to Shifting Performance

Service Category Drivetrain

Section Automatic Transmission/Transaxle

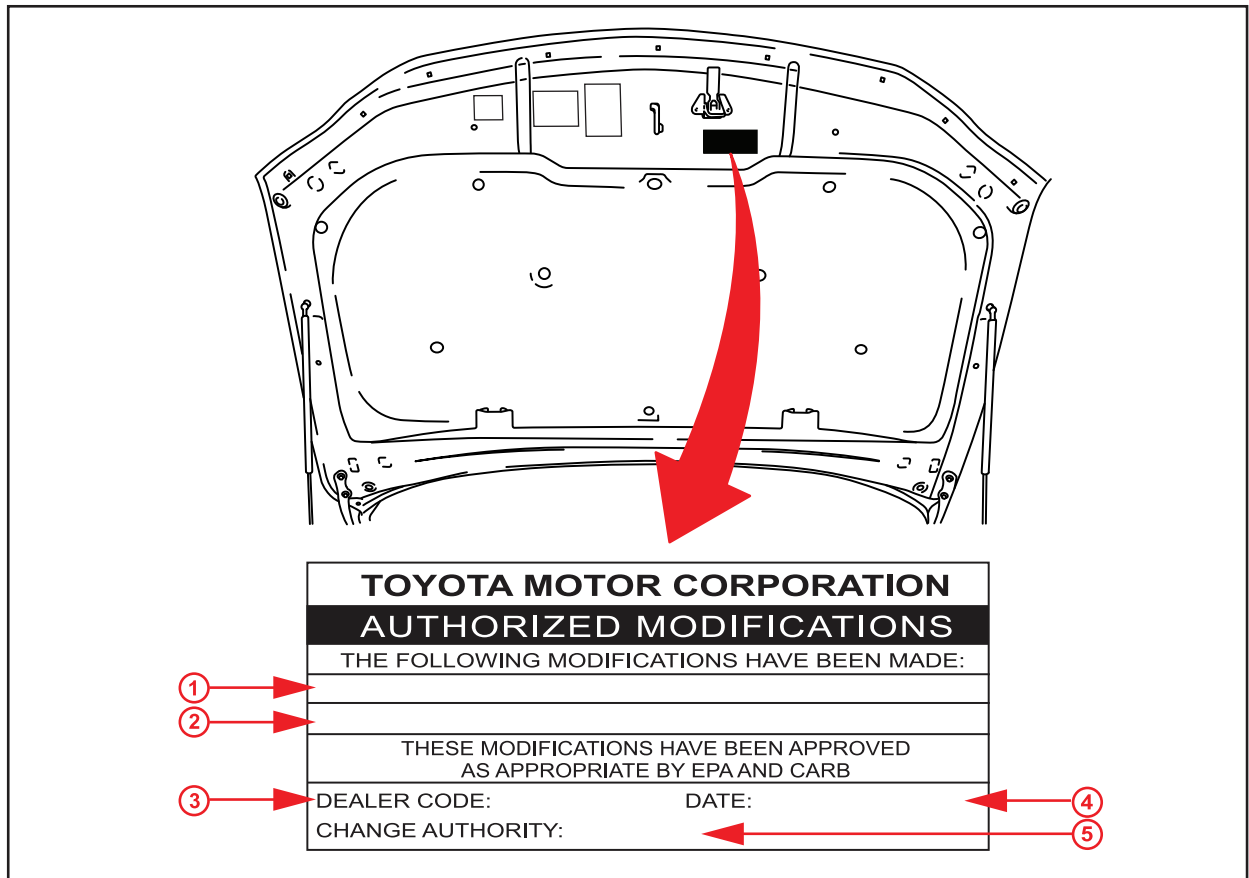
Figure 1. Location of Authorized Modifications Label on 2008 – 2011 LX 570

2. Check for the Authorized Modifications Label affixed to the vehicle in the location shown in Figure 1. Confirm if the ECM (PCM) calibration has been updated. If the calibration ID listed is NOT the latest ECM (PCM) calibration — go to step 3.

4. Install the Authorized Modifications Label.
 - A. Using a permanent marker, enter the following information on the label:
 - ECM part number [*Refer to the **Parts Information** section for the **CURRENT PART NUMBER***]
 - Calibration ID(s) [*Refer to the **Calibration Identification Chart** for the **NEW CALIBRATION ID***]
 - Dealer Code
 - Repair Date
 - Change Authority [***This bulletin number***]
 - B. Affix the Authorized Modifications Label to the vehicle at the location shown in Figure 1. The Authorized Modifications Label is available through the MDC, P/N 00451-00001-LBL.
5. Test drive the vehicle and perform transmission initialization.
