NUMBER: 08-056-12 REV. A

Information On New Radio Systems: Sales Code RA1, RA2, RA3, or RA4

2013 (DS) Ram 1500 Pickup **** (U.S. Market Only) ****

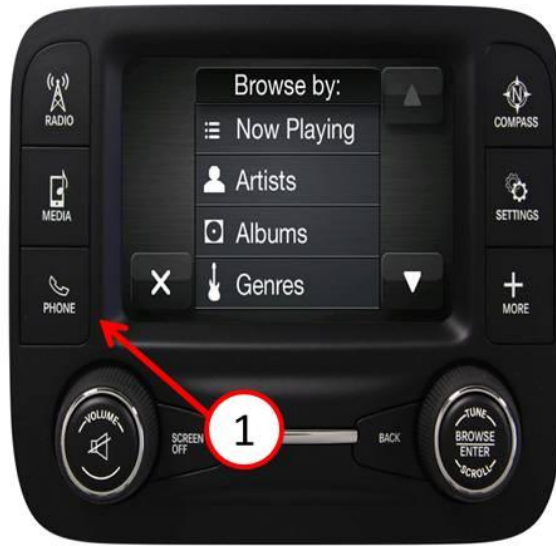
Fig. 2 Radio sales code RA2

1 - RA2 radios will have this phone button.

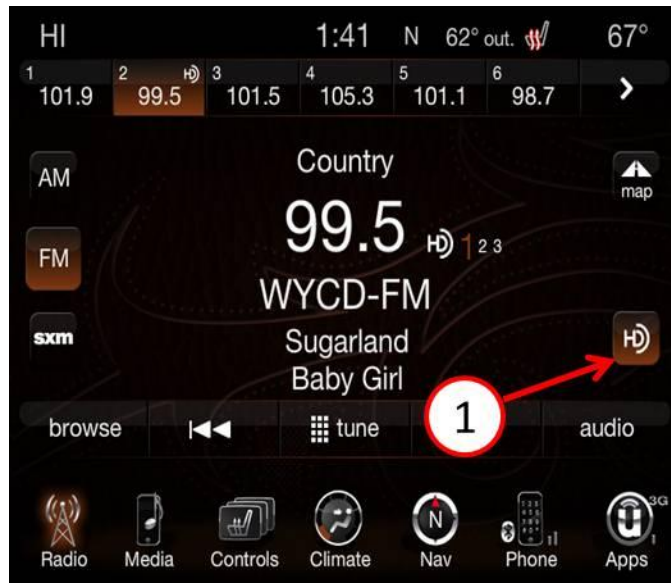
Fig. 4 How to tell if the radios is an RA4

1 - RA4 radios will have this HD) symbol.
