# Service Bulletin

**Subject:** Diagnosis and Repair - Malfunction Indicator Lamp (MIL) Illuminated, Reduced Engine Power Message Displayed, DTC P2135 Set

**Models:** 2008-2011 Cadillac Escalade Models  
2009-2011 Cadillac Escalade Two-Mode Hybrid  
2008-2009 Chevrolet TrailBlazer  
2008-2011 Chevrolet Avalanche, Colorado, Express, Silverado, Suburban, Tahoe  
2008-2011 Chevrolet Tahoe Two-Mode Hybrid  
2009-2011 Chevrolet Silverado Two-Mode Hybrid  
2008-2009 GMC Envoy  
2008-2011 GMC Canyon, Savana, Sierra, Sierra Denali, Yukon Models  
2008-2011 GMC Yukon Two-Mode Hybrid  
2009-2011 GMC Sierra Two-Mode Hybrid  
2008-2009 HUMMER H2  
2008-2010 HUMMER H3  
Equipped with Engine RPO LFA, LY2, L20, LMG, LC9, LH6, LMF, LH8, LH9, L76, LS2, LY5, LY6, L92, L96, LZ1, L94 or L9H

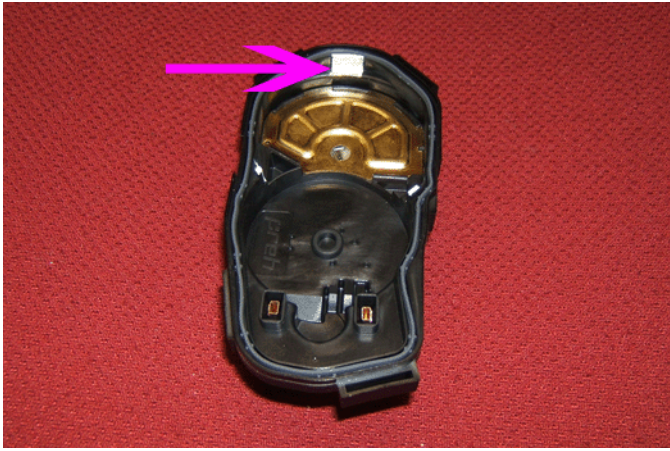
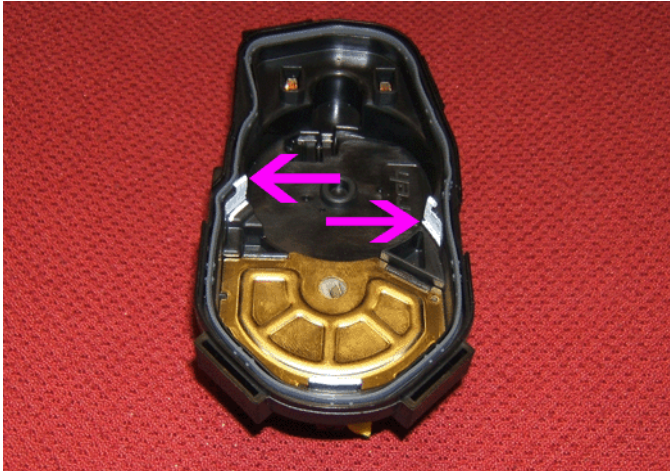
**Notice:** The three TP sensor cover alignment tabs are highlighted in white for identification purposes only.

18. Verify that all three of the TP sensor cover alignment tabs are present and are not damaged.
19. Grasp and hold the throttle body in the previously hand held upward position. Lightly depress the intermediate gear to verify that it is fully seated and the gears are engaged.
