# Service Bulletin

**SUBJECT:** Service Update for Inventory Vehicles Only  
Inspect Seat Memory Switch Retention  
Expires November 30, 2013

**MODELS:** 2013 Cadillac XTS

Subject: 12283 – Service Update Bulletin – Inventory Vehicles Only  
Inspect Seat Memory Switch Retention

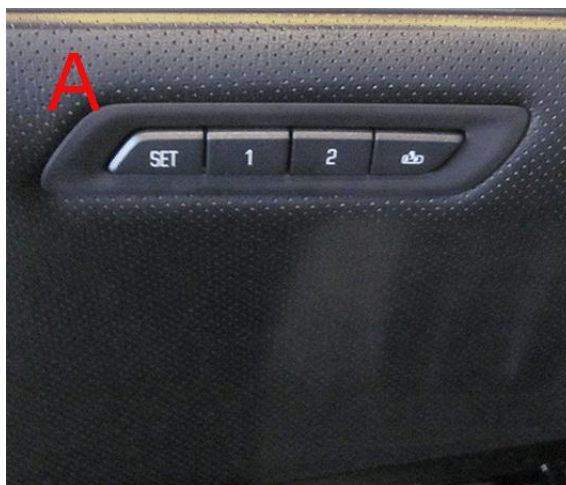
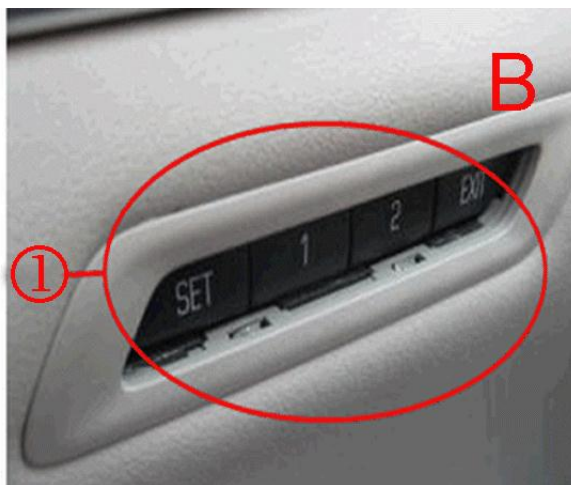
2969444

**(A) Good driver seat memory seat switch. (B) Driver seat memory seat switch requires repair. The buttons (1) are pushed into the door trim panel.**

**Note:** The cause of this condition may be insufficient retention of the seat switch snap features to the switch bracket. Reposition the memory seat switch bracket and add an adhesive back shim stock. Refer to Steps 2-9.

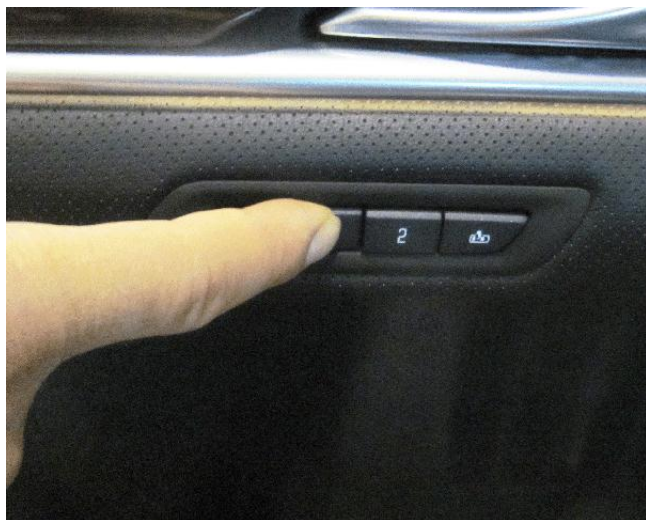
2969446

- 1.2 Firmly depress the driver seat memory seat switch buttons.

- If the driver seat memory seat switch buttons are not pushed into the door trim panel, no further action is required.

- If the driver seat memory seat switch buttons are pushed into the door trim panel, proceed to the next step.
