Service Bulletin

Subject: Front Door Wind Noise

Models: 2013 Chevrolet Sonic

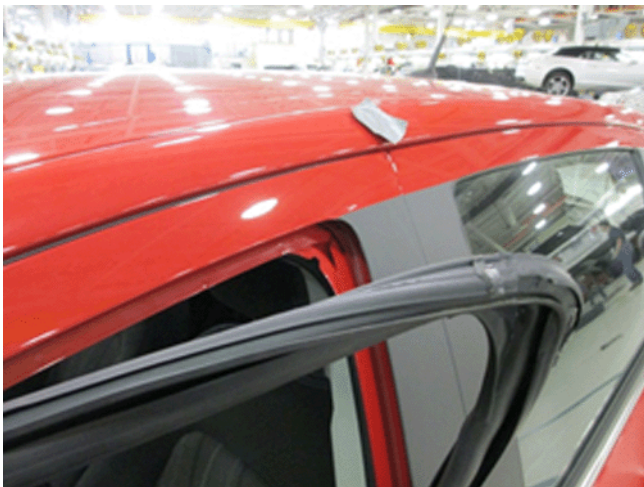
The wind noise may be coming from the die relief notch in the door. Cover the notch with tape following the procedure below:

1. Lower the front door window.
