Service Bulletin

Subject: Information on Seat Back of Driver and Passenger Front Seats Not Matching

Models: 2013 Buick Encore

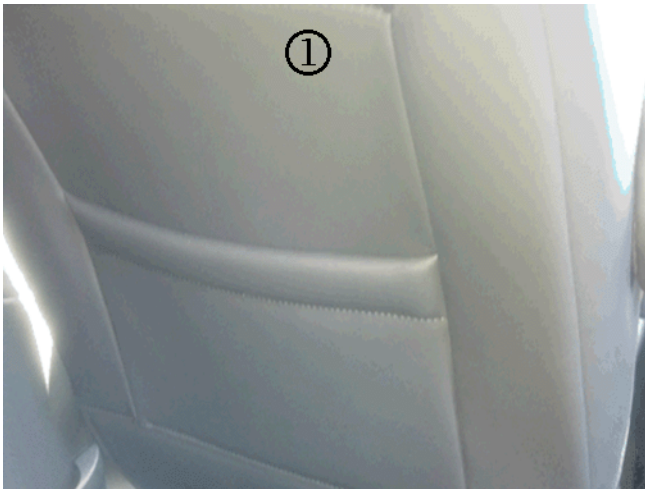
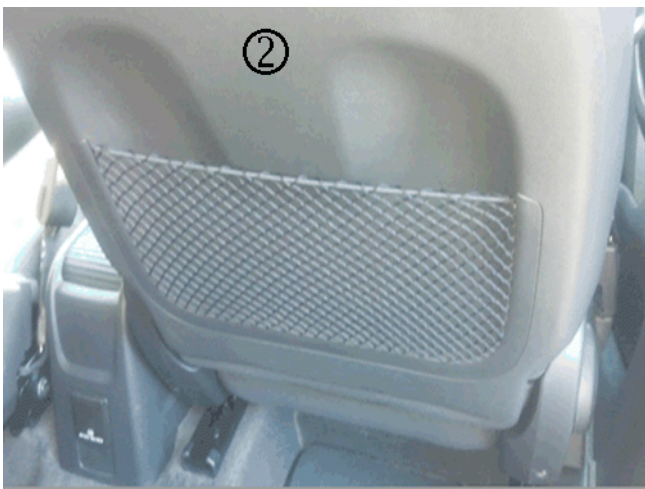
Some customers may comment that the seat back on the driver and passenger front seats do not match.

This occurs by design, with the driver non-folding seat (1) having a soft trim back cover and the passenger seat (2) having a hard plastic back trim for protective purposes, due to its ability to fold flat.

This is a normal condition and NO parts should be replaced as an attempted correction.
