Service Bulletin

PRELIMINARY INFORMATION

Subject: Spare Tire Jack Storage Compartment Door Difficult to Latch or Falls Open Due to Inability to Latch

Models: 2009-2012 GMC Acadia

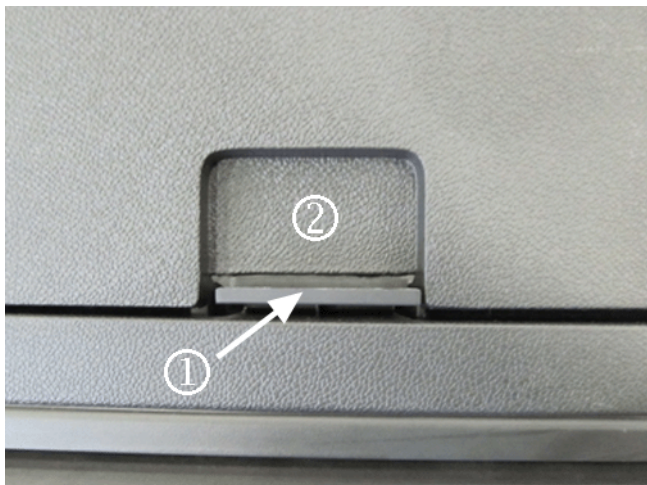
Some customers may comment that the jack storage compartment door may be difficult to latch or may fall open on its own because of improper latching.

The cause of this condition may be that excessive interference may exist between the storage compartment door latch (1) and the body side trim panel (2), not allowing the door to latch properly.
