Service Bulletin

Subject: Information on Inappropriate Warranty Claims Submitted for Damaged Radios and Instrument Panel Clusters (IPCs)

Models: 2013 and Prior GM Passenger Cars and Light Duty Trucks

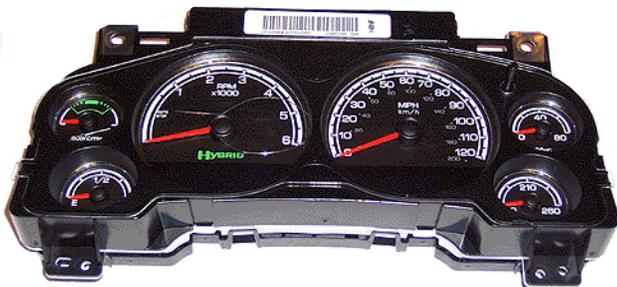
- The illustration above shows an IPC with a cracked lens.

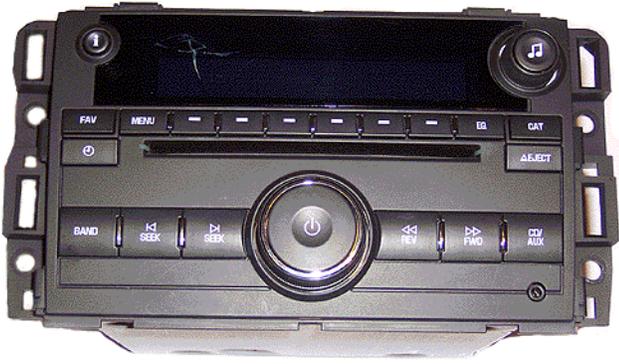
- The illustration above shows a radio with a cracked display window.

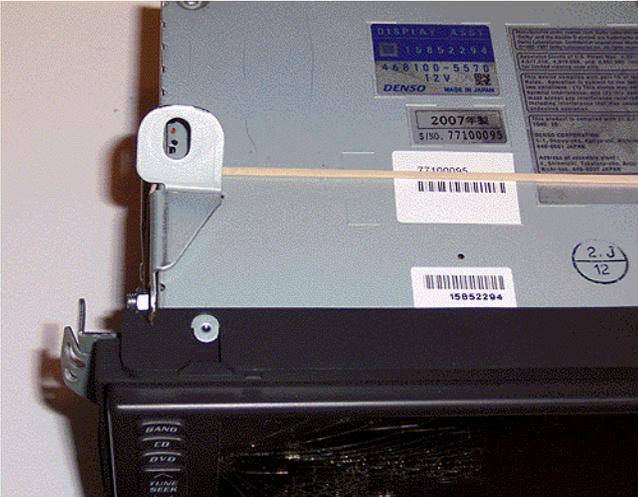
- The illustration above shows a radio with damaged mounting tabs.

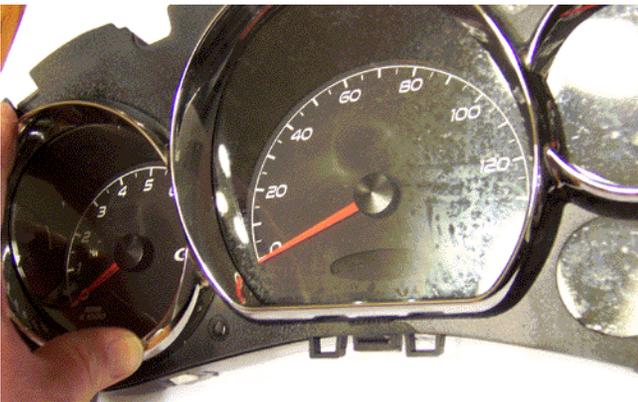
- The illustration above shows an IPC with chemical damage to the lens.

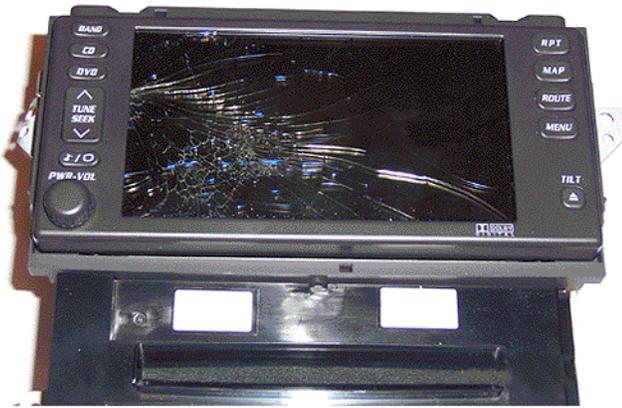
- The illustration above shows a navigation radio with a cracked display window.
