# Service Bulletin

**SUBJECT:** Service Update for Inventory Vehicles Only  
Incorrect Material Used for Transmission O-Ring  
Expires September 30, 2013

**MODELS:** 2012-2013 Buick Regal  
2013 Buick LaCrosse  
2013 Chevrolet Malibu  
Equipped with 6-Speed Hybrid Automatic Transmission (MHH)

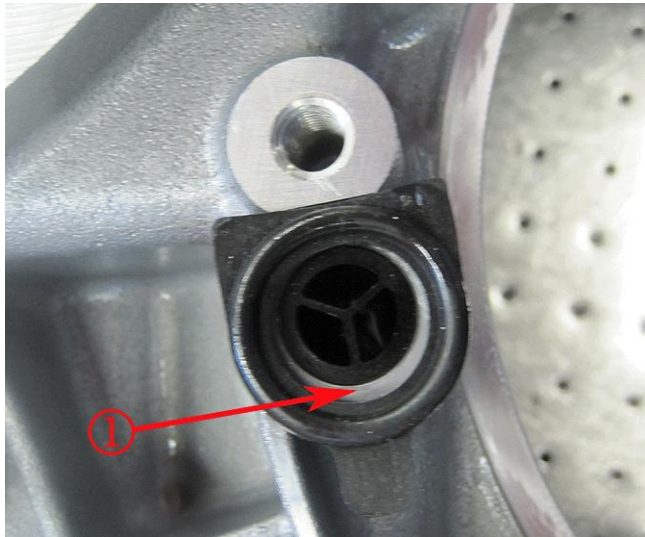
2913458

**Note:** The fluid inlet pump seal (1) may be torn as shown in the photo below.

1. Install a new A/Trans Auxiliary Fluid Inlet Pump Seal (8).
