**SUBJECT:** Service Update for Inventory and Customer Vehicles  
Front Seat Cushion Trim Retention  
Expires with Base Warranty

**MODELS:** 2013 Cadillac XTS

Subject: 12290 – Service Update Bulletin  
Front Seat Cushion Trim Retention

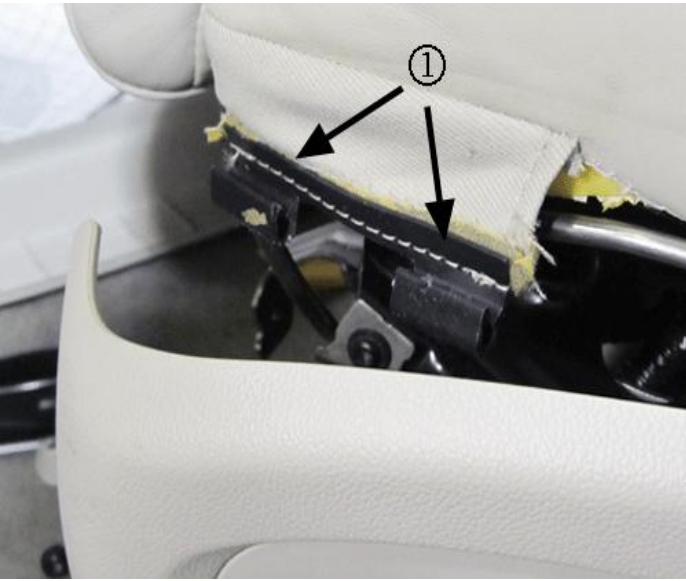
2910863

Note: Some seats may have a single hog ring (1) at either or both front corners of the seat.

- For the outboard corner repair, it will be necessary to remove this hog ring to fully release the J-channel from the seat frame.
- For the inboard corner repair, leave the existing hog ring intact.

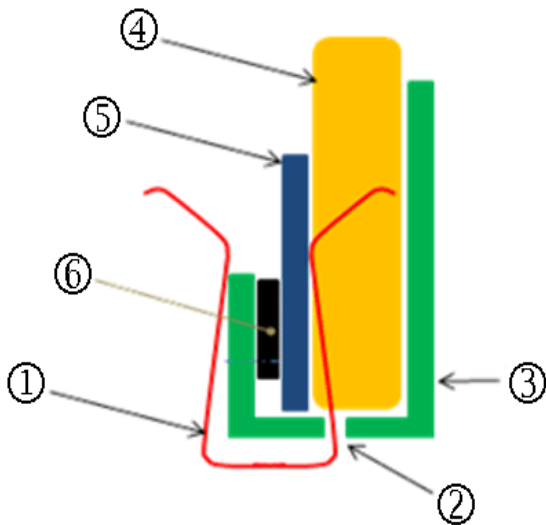
2965484

Note: A cross section of the clip installation is shown in the illustration above. Ensure the clip (1) is inserted through the slit (2) in the seat material (3), between the foam (4) and the seat frame (5), capturing the material and J-channel (6).

- 5.2. Using a utility knife or similar tool, cut a slit in the material fabric along the bottom edge of the J-channel, about half the width of the channel.
- 5.3. Reinstall the J-channel to the front corner of the seat frame.

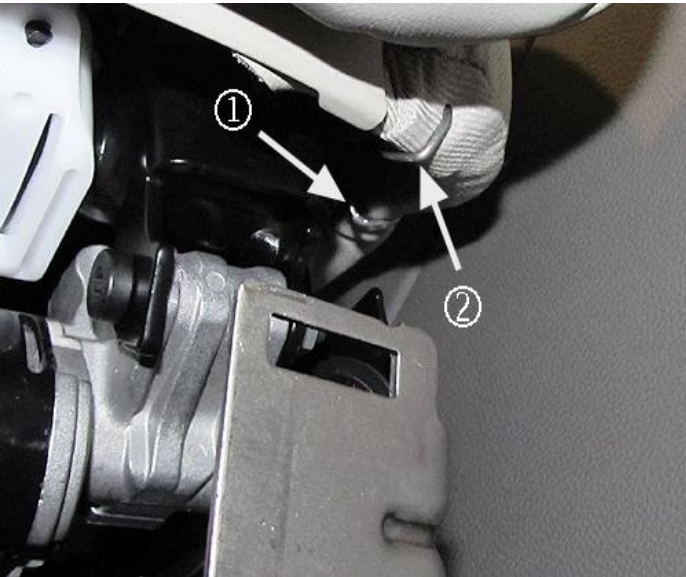
2968977

**Note:** The graphic above shows the original (1) and the added hog ring (2) on the passenger front seat.

6. Add a hog ring, or equivalent, to the inboard front corner of the cushion cover and J-channel. Snap the hog ring around the front end of the J-channel and the seat frame as shown in the graphic above.
