# Service Bulletin

**Subject:** Accessory Soft Tonneau Cover Loose

**Models:** 2004-2012 Chevrolet Colorado  
2007-2013 Chevrolet Silverado  
2004-2012 GMC Canyon  
2007-2013 GMC Sierra

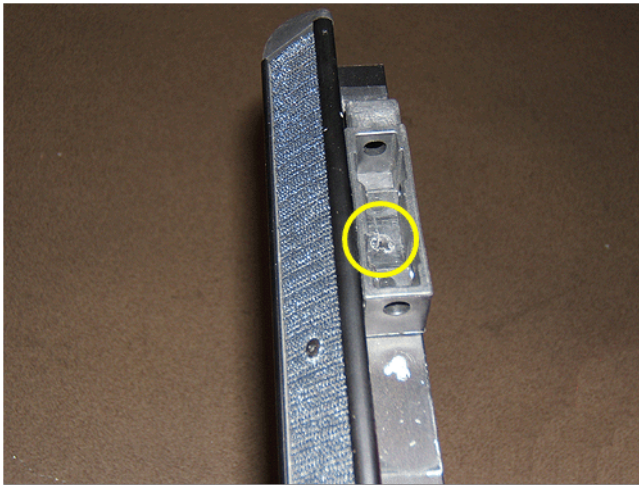
A rivet (location shown circled in the graphic above) that retains the pivot blocks to the side rail assembly may have loosened or detached.

Do This	Don't Do This
Install new pivot block rivets to side rail assembly.	DO NOT replace the tonneau cover or side rails.

**Important:** When a pivot block rivet is found to be loose on either end of a tonneau side rail, always replace the rivets on BOTH of that rail's pivot blocks.
