Service Bulletin

PRELIMINARY INFORMATION

Subject: Navigation Radio Will Not Display Map Data, Message Display is On

Models: 2011 Cadillac Escalade Models
Equipped with Navigation Radio (RPO GMQ)

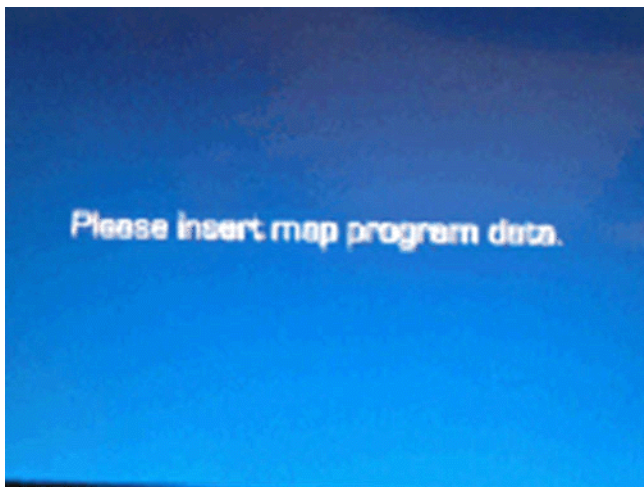
- Most commonly, the system continuously shows the "Updating in Progress" screen.

The cause of this condition may be anomalies in the software.

Do This	Don't Do This
Install the 2012 MY, (version 2012), or Newer Nav Service Compact Flash Card and load software into the radio.	DO NOT replace the radio.
