## Subject: National Seating Seat Suspension Welds

**Models Affected:** Specific Freightliner Cascadia and Western Star 4900 vehicles manufactured December 21, 2011, through February 23, 2012, with certain National Seating seats.

# Recall Campaign

November 2012  
FL624A-C  
NHTSA #12V-138  
Transport Canada #12-113

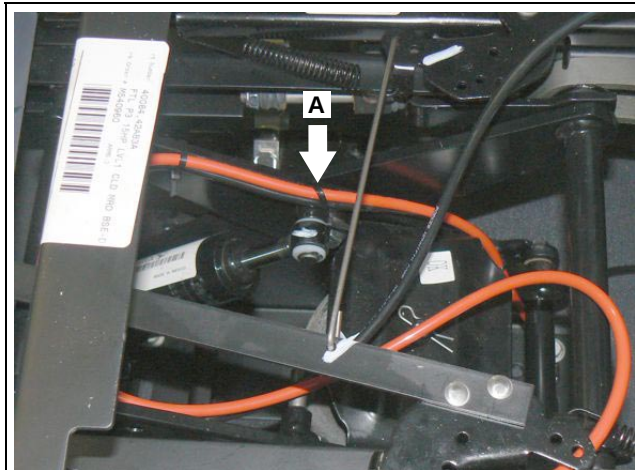
**Fig. 1, Upper Shock Absorber Mounting Post, Non-Swivel Seats**

- A. Cut the zip tie that attaches the air lines to the shock mounting post.

5. Lift up the seat cushion.
6. Cut and remove the zip tie that attaches the air lines to the shock mounting post. See **Fig. 1** for non-swivel seats or **Fig. 2** for swivel seats.

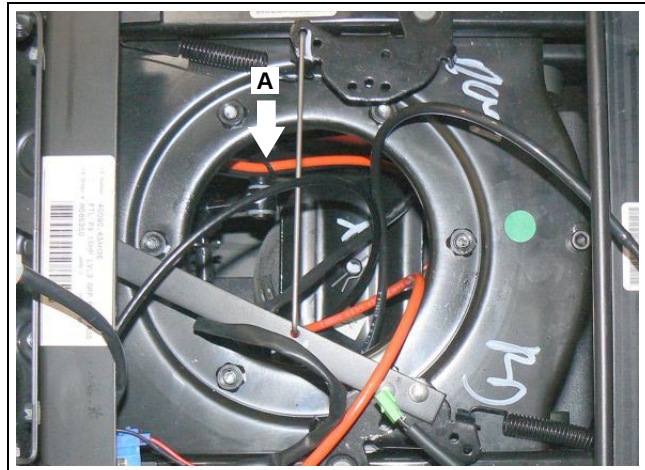
**Fig. 2, Upper Shock Absorber Mounting Post, Swivel Seats**

- A. Cut the zip tie that attaches the air lines to the shock mounting post.

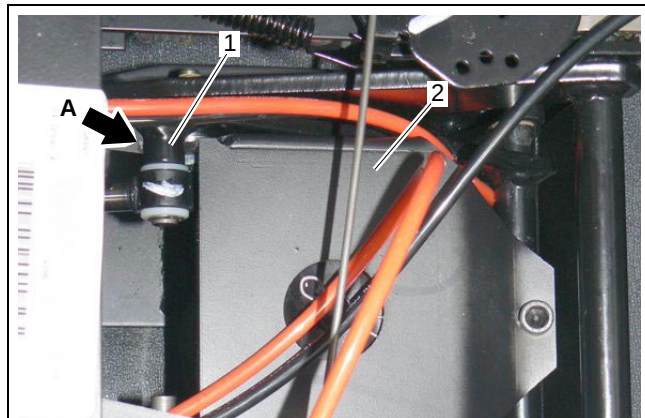
**Fig. 4, Reinforcement Bracket Installation (view from above)**

- A. Set the hooked spurs underneath the shock mounting posts.

7. From behind the seat, install the reinforcement bracket ( **Fig. 3** ) on top of the upper air spring bracket, with the hooked spurs underneath the shock mounting posts. Lift the seat cushion and view the installation from above, to make sure that no air lines or wires are pinched or snagged. See **Fig. 4**.
